Technical Journal

Side door rear, water intrusion

REF NO: TJ 31542.7.0	ISSUING DEPARTMENT: Technical Service	CAR MARKET: United States and Canada	
PARTNER: 3 US 7510 Volvo Car USA		ISSUE DATE: 2017-04-28	STATUS DATE: 2017-04-28
FUNC GROUP: 8400	FUNC DESC: Outside trim parts, glass, sealing mould	Page 1 of 10

Title	Weatherstrip, door window, rear	Page	1 (5)
Action	Adjustment	Operation number:	98630-2

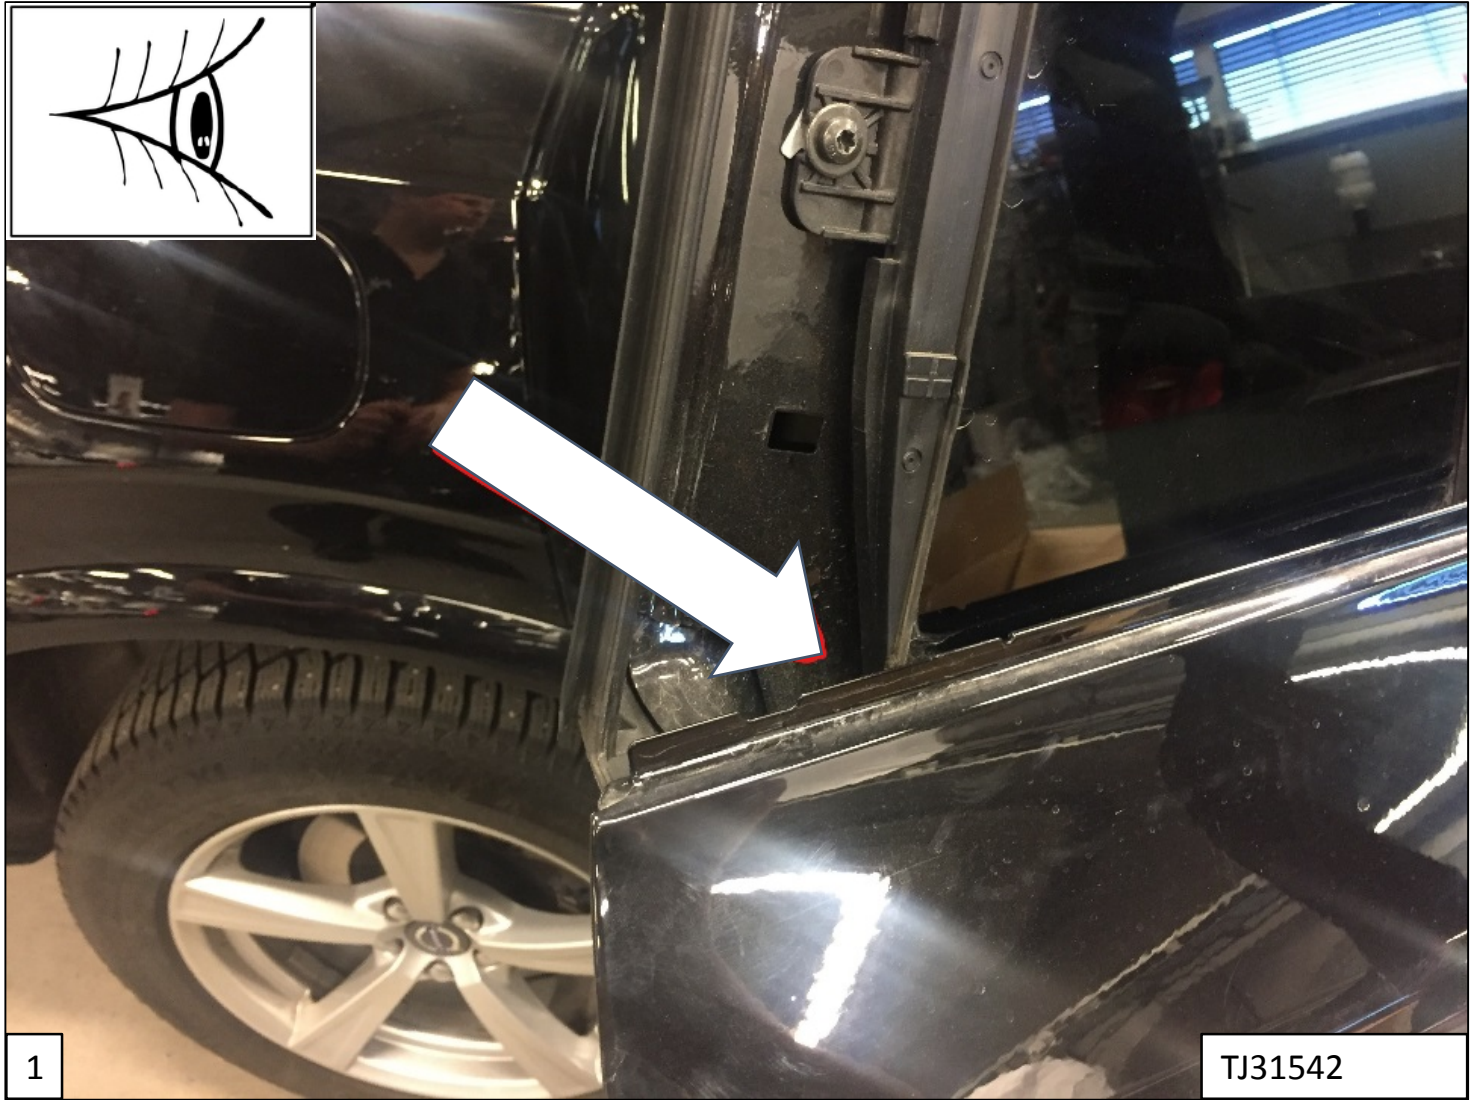
1

If it's still leaking, it's recommended to inspect the foam piece inside the door so its installed correctly according to attached picture. (see VIDA for Q glass removal).
