Subject: KNOCKING / SQUEAKING NOISE FROM FRONT SHOCK ABSORBER, CREAKING NOISE FROM FRONT LOWER ARM BUSHING	Bulletin No: 02-003/17
	Last Issued: 01/13/2017

APPLICABLE MODEL(S)/VINS

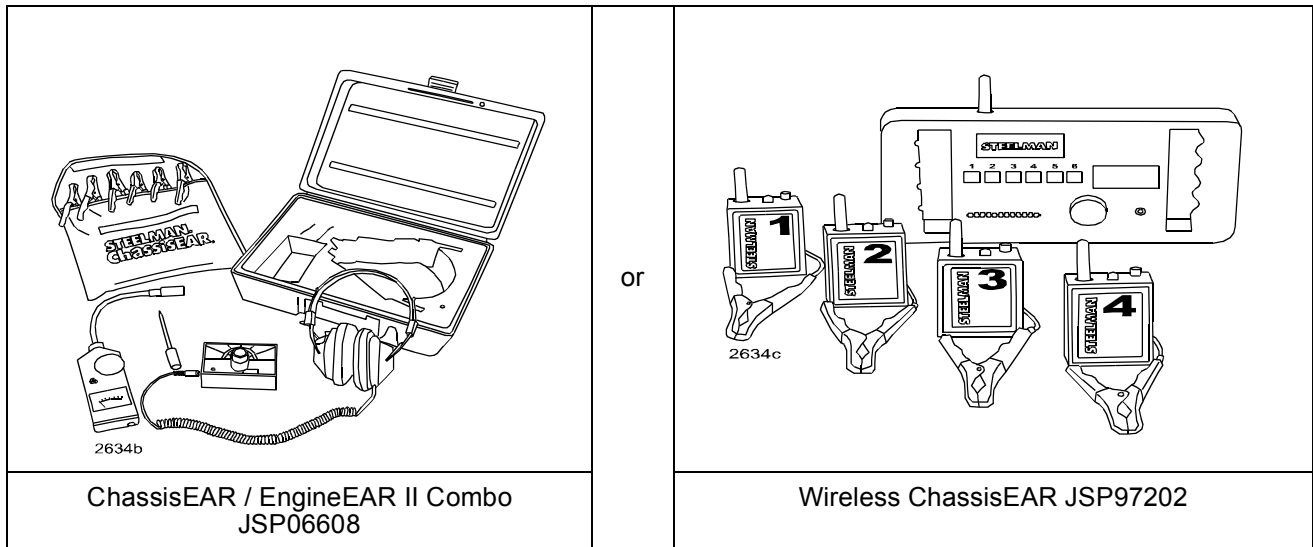
1. Use Special Service Tool (SST) ChassisEAR / EngineEAR II Combo JSP06608 or Wireless ChassisEAR JSP97202 to confirm noise is coming from the front suspension when driving over bumps and/or turning the steering wheel while the vehicle is stopped:
