Technical Service Bulletin

Subject: A/C BLOWS WARM AIR	Bulletin No.: 07-001/17
	Last Issued: 02/15/2017

2016-2017 CX-3 vehicles with VINs lower than JM1 DK ***** 159395 (produced before November 01, 2016)

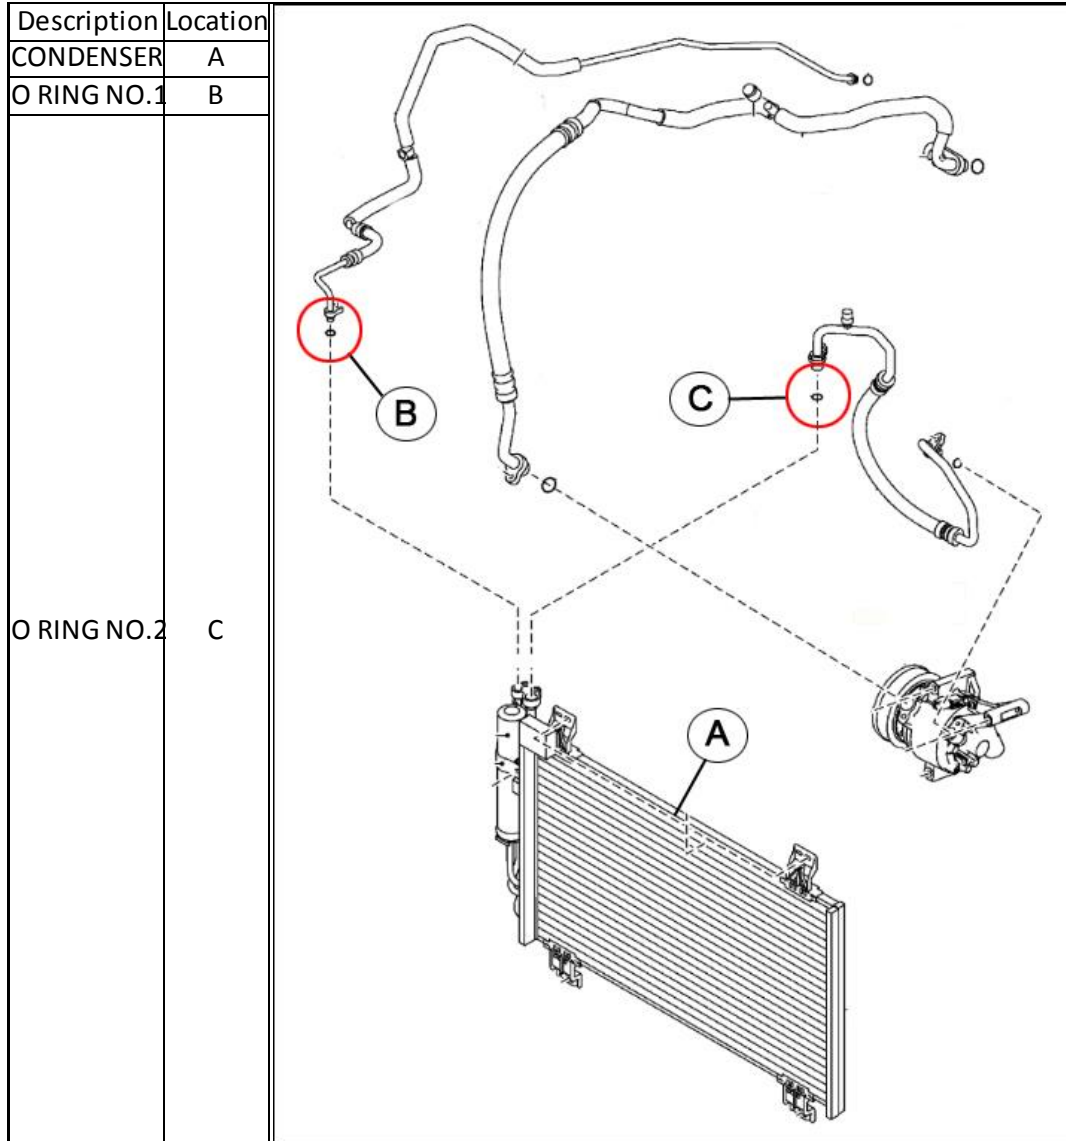
REPLACEMENT PARTS LOCATION

Some customers may complain about warm air from the climate control vents. This may be caused by condenser corrosion, causing a refrigerant leak.

3. Replace the condenser. Refer to MS3 online Workshop Manual CONDENSER REMOVAL/INSTALLATION [SKYACTIV-G 2.0].
