**IB17-X-001A**

## INTRODUCTION TO FTR

- 2018MY Isuzu FTR

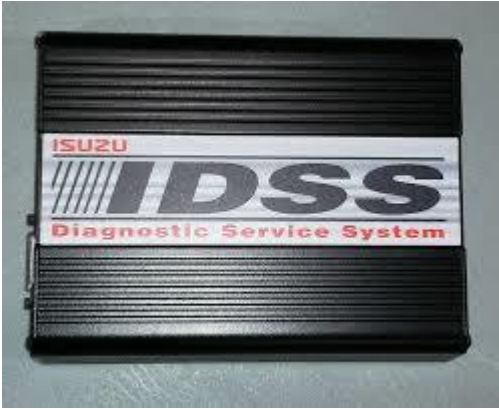
| No. | Description | ECUs | IDSS Interface/Scan Tool |
|---|---|---|---|
| 1. | The metal case IDSS interface will only communicate with the listed Electronic Control Units (ECUs). | <p>Engine Control Module (ECM)</p> <p>DEF Control Module (DCU)</p> <p>Mimamori ECU</p> <p>Fleet Management System (if equipped) (FMS)</p> | |

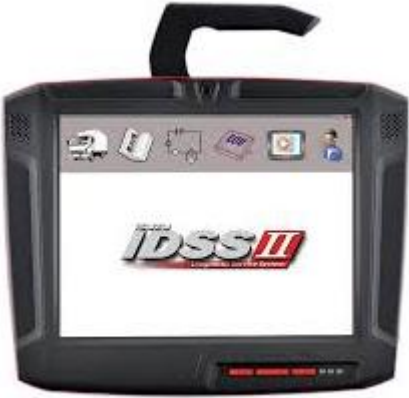
| No. | Description | ECUs | IDSS Interface/Scan Tool |
|---|---|---|---|
| 2. | The IDSS Tablet will communicate with all onboard ECUs. | <p>ECM</p> <p>DCU</p> <p>Mimamori ECU</p> <p>Electronic Brake Control Module (EBCM)</p> <p>FMS (if equipped)</p> | |

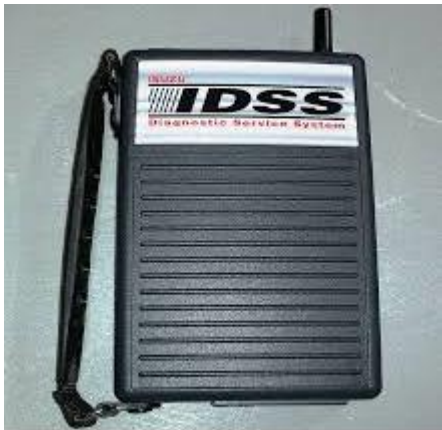
| 3. | The plastic case IDSS interface will communicate with all onboard ECUs. | ECM<br>DCU<br>Mimamori ECU<br>EBCM<br>FMS (if equipped) | |

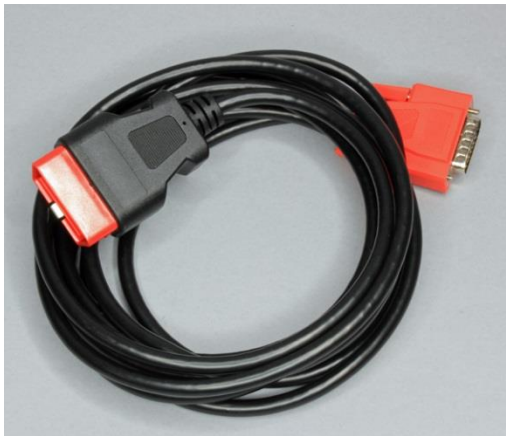
| 4. | A new interface cable with double red ends is required for complete communication with all onboard ECUs. | ECM<br>DCU<br>Mimamori ECU<br>EBCM<br>FMS (if equipped) | |

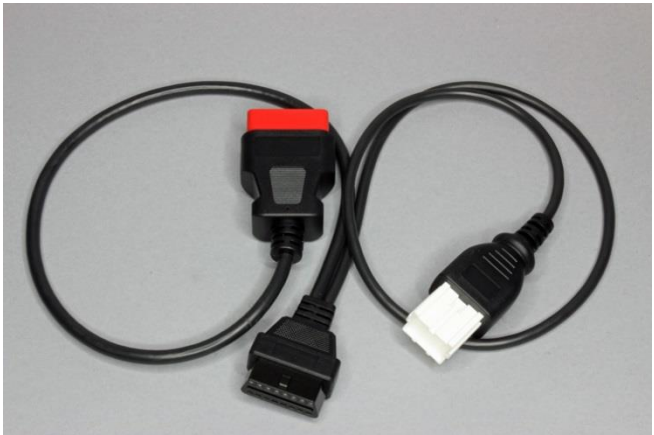
| 5. | A new interface Y-cable is required for complete communication with all onboard ECUs. | ECM<br>DCU<br>Mimamori ECU<br>EBCM<br>FMS (if equipped) | |
