LTB01093NAS2

TECHNICAL BULLETIN

501-03: Body Closures

Tailgate - Cosmetic Microcracking

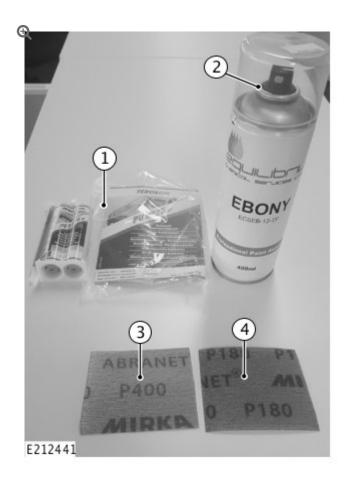
Contents of the repair kit.

- (1) TEROSON PU 9225 filler
- (2) EQUILIBRIUM spray paint
- **(3)** Sandpaper P400
- **4)** Sandpaper P180
