GROUP	NUMBER	
CAMPAIGN	18-01-003	
DATE	MODEL(S)	
JANUARY, 2018	IONIQ ELECTRIC (AE EV)

CHARGING CONNECTOR LOCK/UNLOCK ACTUATOR REPLACEMENT (SERVICE CAMPAIGN T2T)

This bulletin provides the service procedure to replace the charging connector lock/unlock actuator.

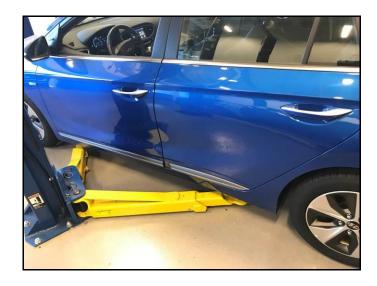
1. Align the vehicle onto the lift. Do not lift the vehicle up.

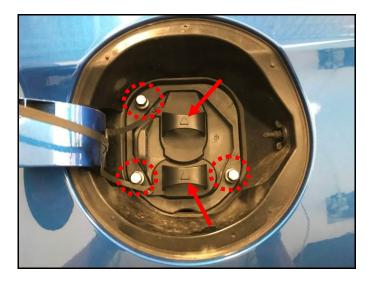
- Wait 5 minutes to allow the high voltage battery capacitor to fully discharge.
- 9. Remove the three 10mm nuts holding the charger port and pull the charger port plugs.

Quick charging port mounting bolt tightening torque: 8.0~10.1 lb-ft (10.8~13.7 Nm, 1.1~1.4 kgf.m)

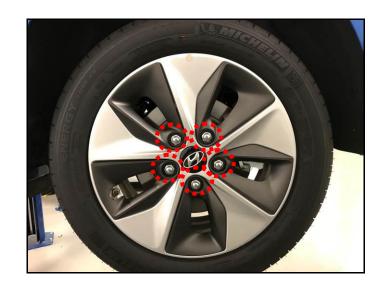
11. Remove the rear driver's side wheel by removing the 5 lug nuts.

> Lug nut tightening torque: 79.6~94.0 lb-ft (107.9~127.5 Nm, 11.0~13.0 kgf.m)

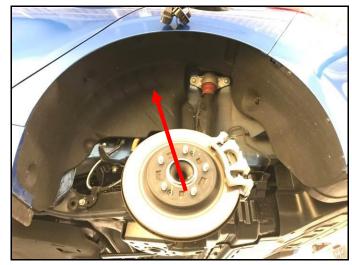
TSB #: 18-01-003 Page 5 of 8 12. Remove the wheel well liner by removing the three types of fasteners located in the picture to the right.

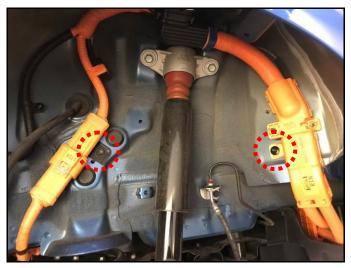
13. Remove a 10mm bolt and a 10mm nut to loosen the charging wiring harnesses.

Quick charging port bracket mounting nut/bolt tightening torque: 7.2~8.7 lb-ft (9.8~11.8 Nm, 1.0~1.2 kgf.m)

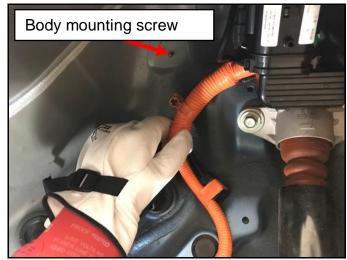
Loosen the harnesses by pulling them out of the body mounting screws.

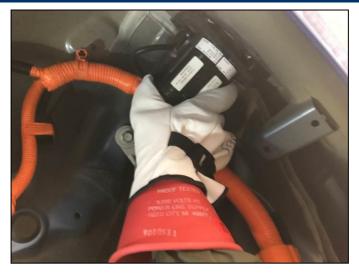
14. Carefully pull the charging port away from the fender and wiggle downward to release the charging port.
