MODEL  
2018MY  
Stinger (CK)

NUMBER  
178 (Rev 1, 1/30/2018)

SUBJECT: SERVICE ACTION: RATTLE NOISE  
FROM TAILGATE (SA322)

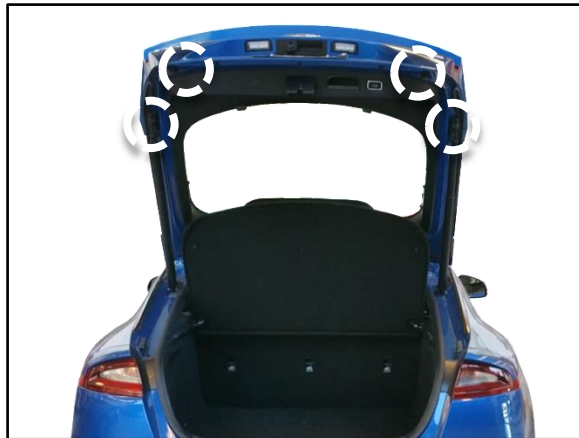
This bulletin provides the procedure to adjust the overslam bumpers and install a guide bumper mounting kit on some 2018MY Stinger (CK) vehicles, produced from September 21, 2017 through January 4, 2018, which may exhibit a rattle noise while driving, especially over bumps. Follow the procedure outlined in this bulletin to adjust the overslam bumpers and install a guide bumper mounting kit. Before conducting the procedure, verify that the vehicle is included in the list of affected VINs.
