MODEL
2018MY
Optima (JFa)

NUMBER
182 (Rev 1, 1/11/2018)

TECHNICAL SERVICE BULLETIN

SUBJECT: SERVICE ACTION: FLOOR CONSOLE INNER PANEL
INSPECTION & CORRECTION/REPLACEMENT (SA328)

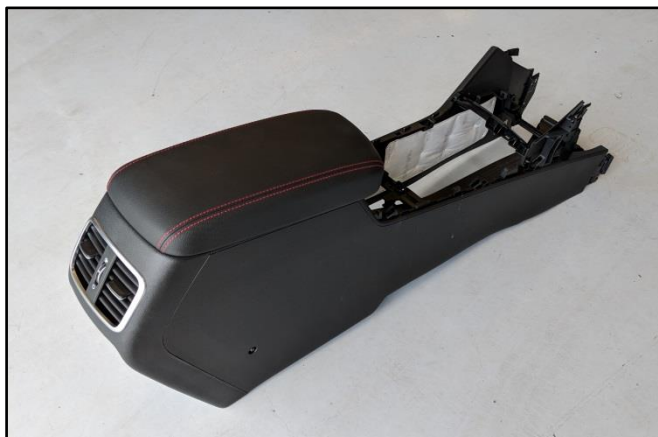
Carefully place the floor console assembly on the floor over a non-grating surface or a protective cloth to prevent any damage to the console.

1. Remove the Floor Console Assembly by referring to the “Body (Interior and Exterior) → Floor Console → Floor Console Assembly → Repair procedures” chapter in the applicable Shop Manual on KGIS.

2. Remove and set aside (for reuse) the seven (7) panel retaining bolts (C) and remove both of the inner floor console (LH & RH) side panels (A) & (B).
