**Campaign code.**

L73X-A.02.18

**Subject.**CarPlay Upgrade**Model.**Aventador S Coupè and Aventador Roadster equipped with CarPlay;**Model year.**2017.2018**Special or Limited Versions.**All;**Markets.**

Automobili Lamborghini Spa has released a software update that will provide to activate the CarPlay on cars where this is not active and will correct small operating bugs.

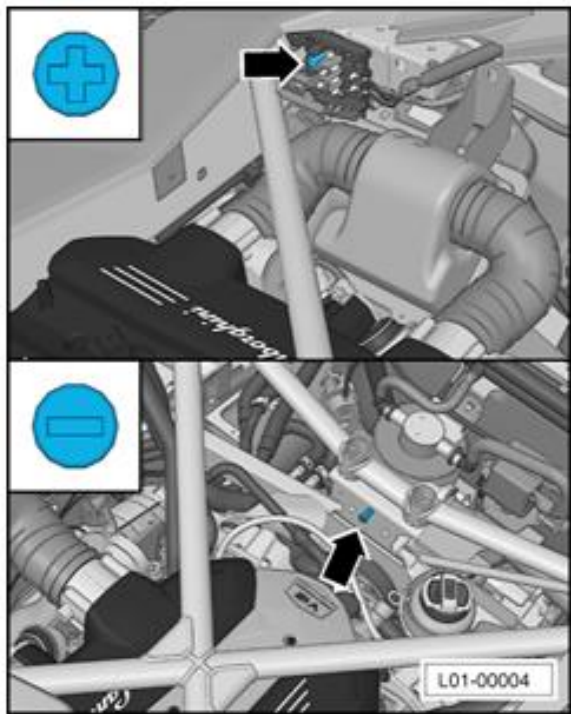
- Please connect a battery charger to the recharge points available in the engine bonnet, as shown in picture.

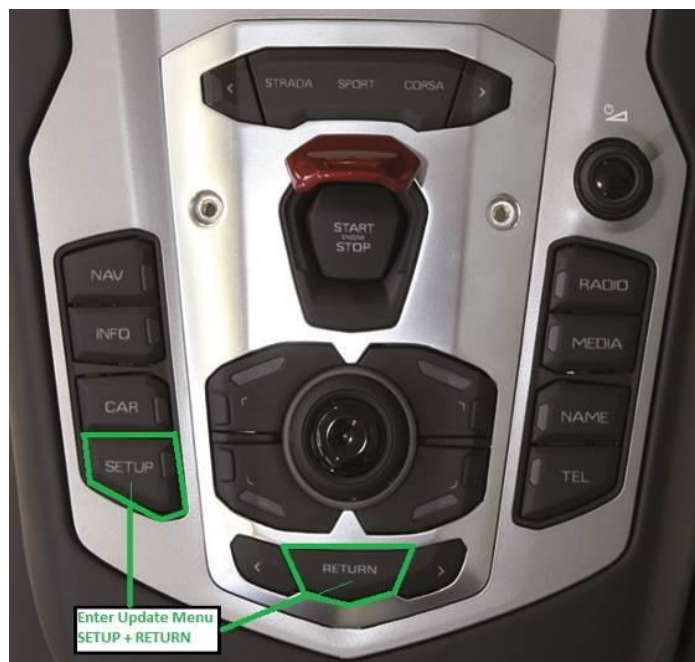
4. Access into update menu with the SETUP + RETURN key combination.

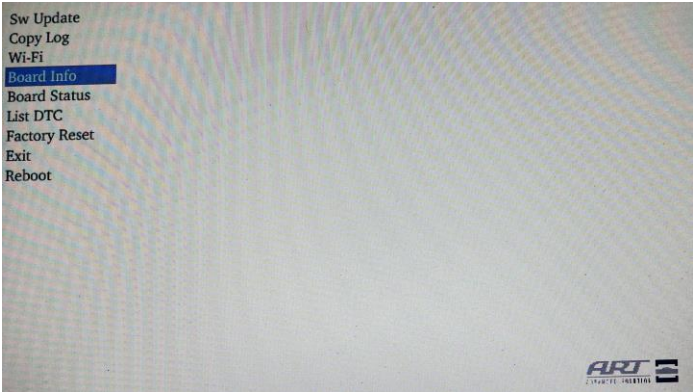
33. On the MMI screen will be shown the following page. Select "Board Info", using the main knob, checking the TSU software version.

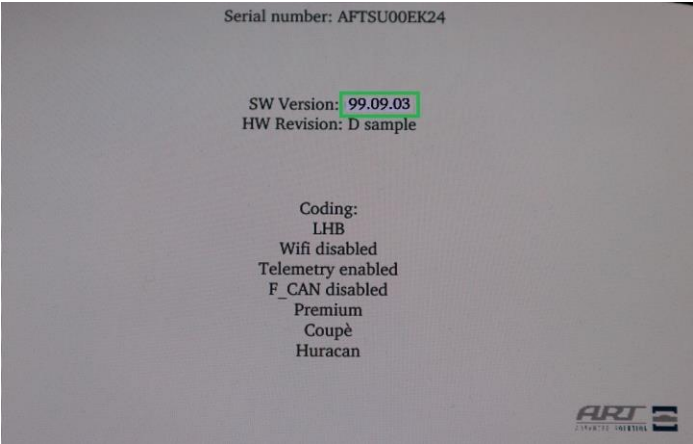
34. If the TSU current version is 99.xx.xx (e.g.99.09.03) you can execute the “Direct Update”.  
Please skip to step 48.

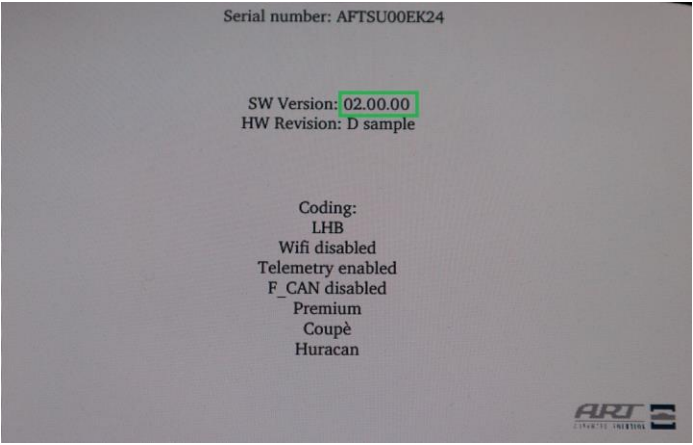
35. If the TSU current version is 02.00.00 you shall performe an “Intermediate Update”, it means you have to flash twice the TSU.

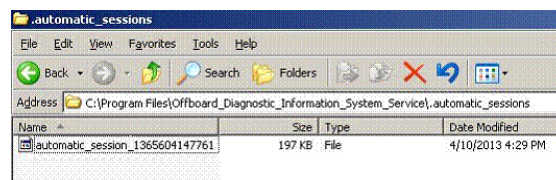
I. In the case the flash container is not detected (see figure):

- Make sure to be recently synchronized with Mirrorserver by checking the last date of Sync under:
