ITB18-004

January 25, 2018

VOLUNTARY SERVICE CAMPAIGN 2018 Q60 SPORT; POWER STEERING CONTROL MODULE REPROGRAMMING

CAMPAIGN ID #: P8301**APPLIED VEHICLES:** 2018 Q60 Sport (V37) equipped with RWD
2018 Q60 Red Sport (V37) equipped with RWD

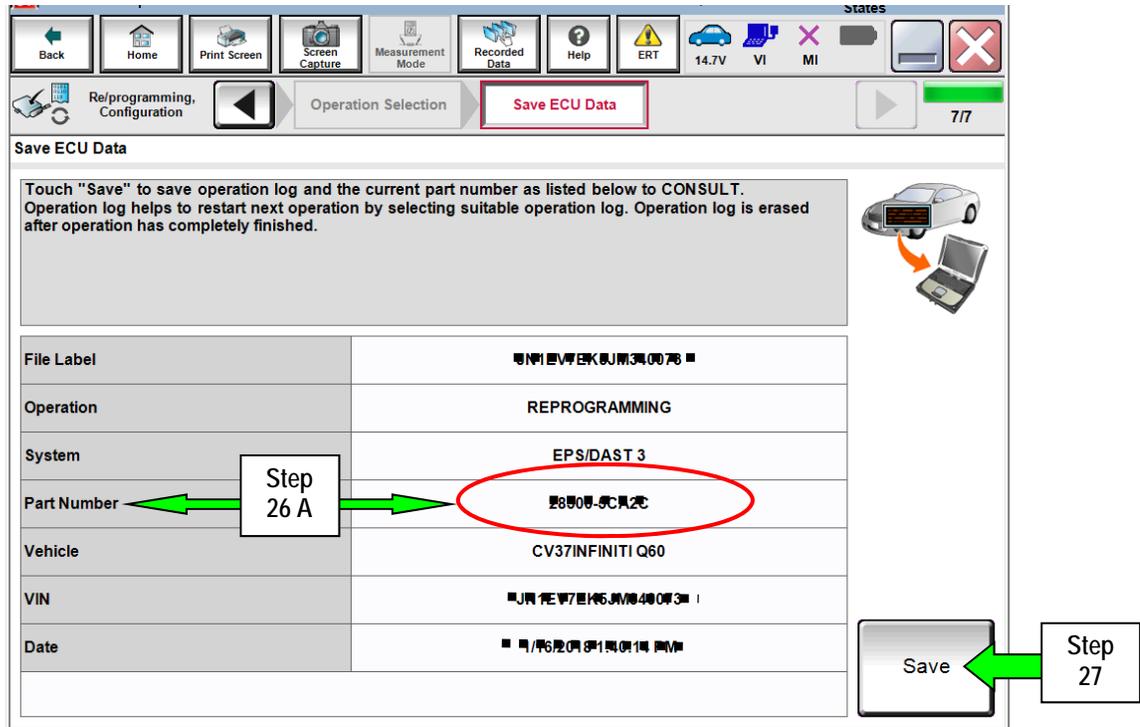
Figure 15

26. When you get to the screen shown in Figure 15, confirm reprogramming is needed as follows:

A. Find the Power Steering Control Module **Part Number** and write it on the repair order.

NOTE: This is the current Part Number (P/N).

B. Compare the P/N you wrote down to the numbers in the **Current Power Steering Control Module Part Number** column in **Table A** below.

- If there is a match, continue with the reprogramming procedure.
- If there is not a match, reprogramming is not needed or it has already been done. Confirm this campaign applies to the vehicle you are working on.

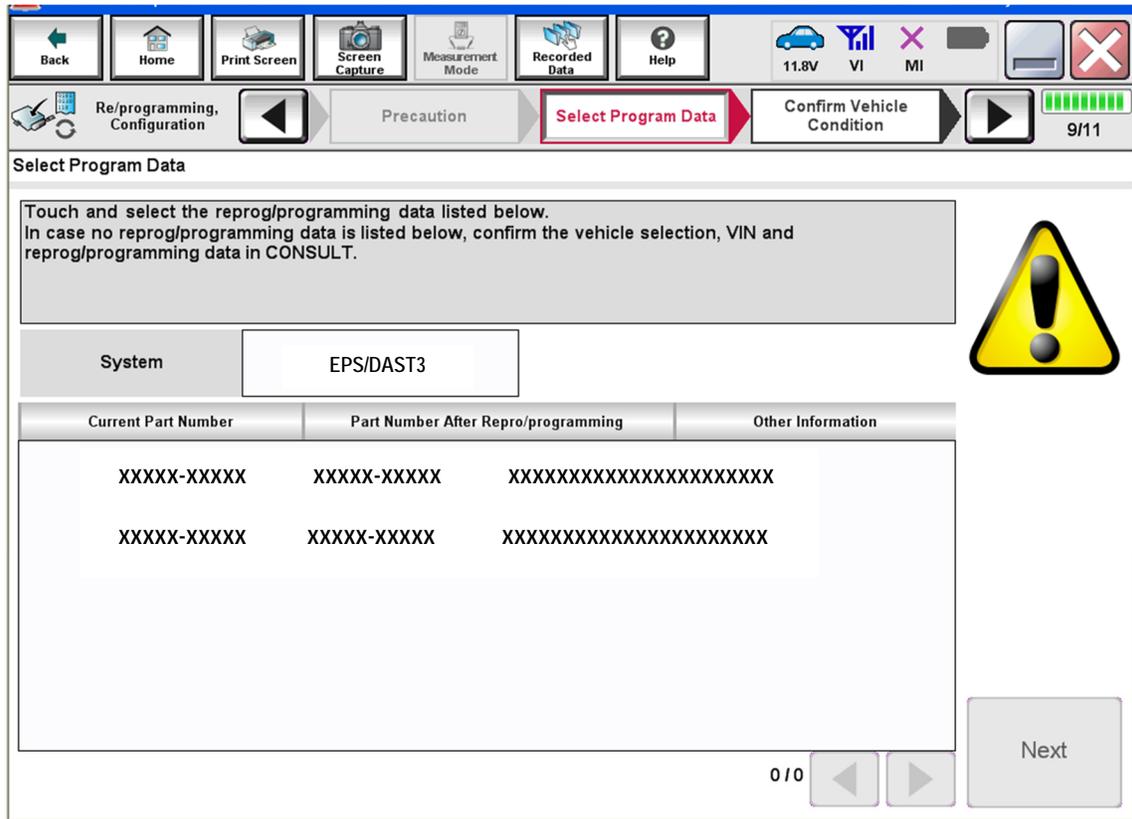
IMPORTANT: If you get the screen shown in Figure 18 and it is blank (no reprogramming listed), it means there is no matching power steering control module reprogramming available for this vehicle (**Power Steering Control Module Reprogram** is not needed).

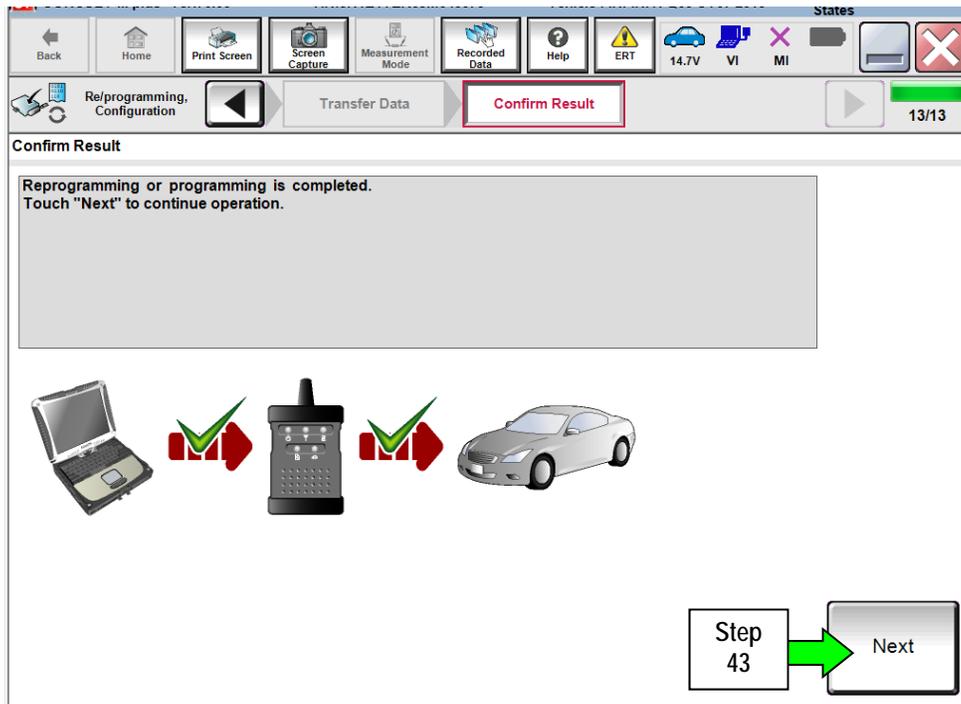
41. When the screen in Figure 24 displays, the reprogramming is complete.

NOTE: If the screen in Figure 24 does not display (indicating that reprogramming did not complete), refer to the information on the next page.

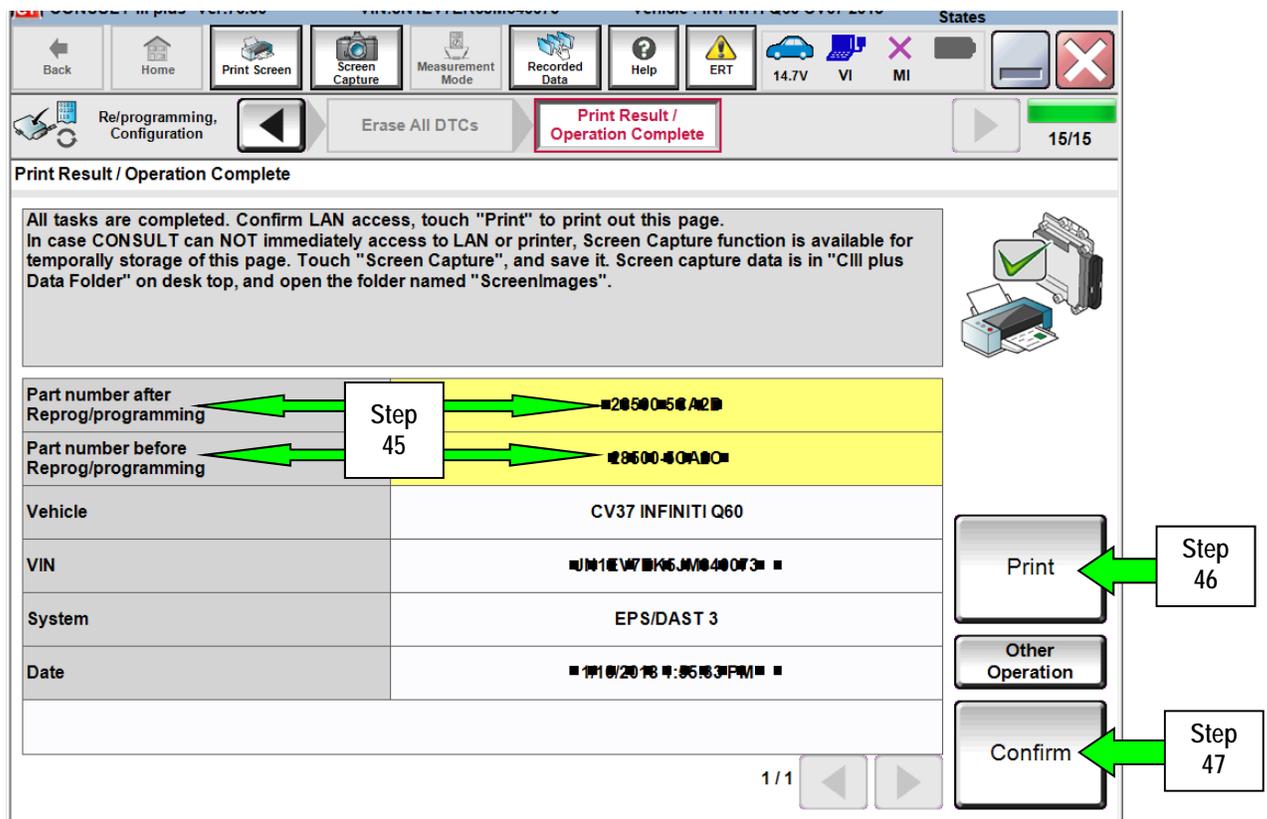
Figure 28

45. Verify the before and after part numbers are different.

46. Print a copy of this screen (Figure 28) and attach it to the repair order for warranty documentation.
