Technical Service Bulletin

Subject:

KNOCKING / SQUEAKING NOISE FROM FRONT SHOCK ABSORBER, CREAKING NOISE FROM FRONT LOWER ARM BUSHING Bulletin No.: 02-002/18

Last Issued: 01/05/2018

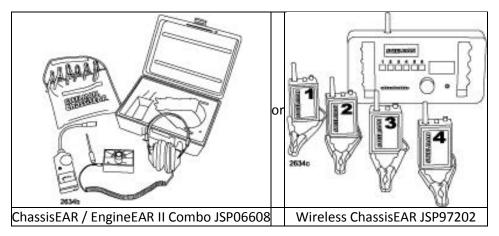
1. Use Special Service Tool (SST) ChassisEAR / EngineEAR II Combo JSP06608 or Wireless ChassisEAR JSP97202 to confirm noise is coming from the front suspension when driving over bumps and/or turning the steering wheel while the vehicle is stopped:
