**PREVOST**

## WARRANTY BULLETIN

**WB17-16**

| SUBJECT : | C15 & C58 CONNECTOR BYPASS | | |

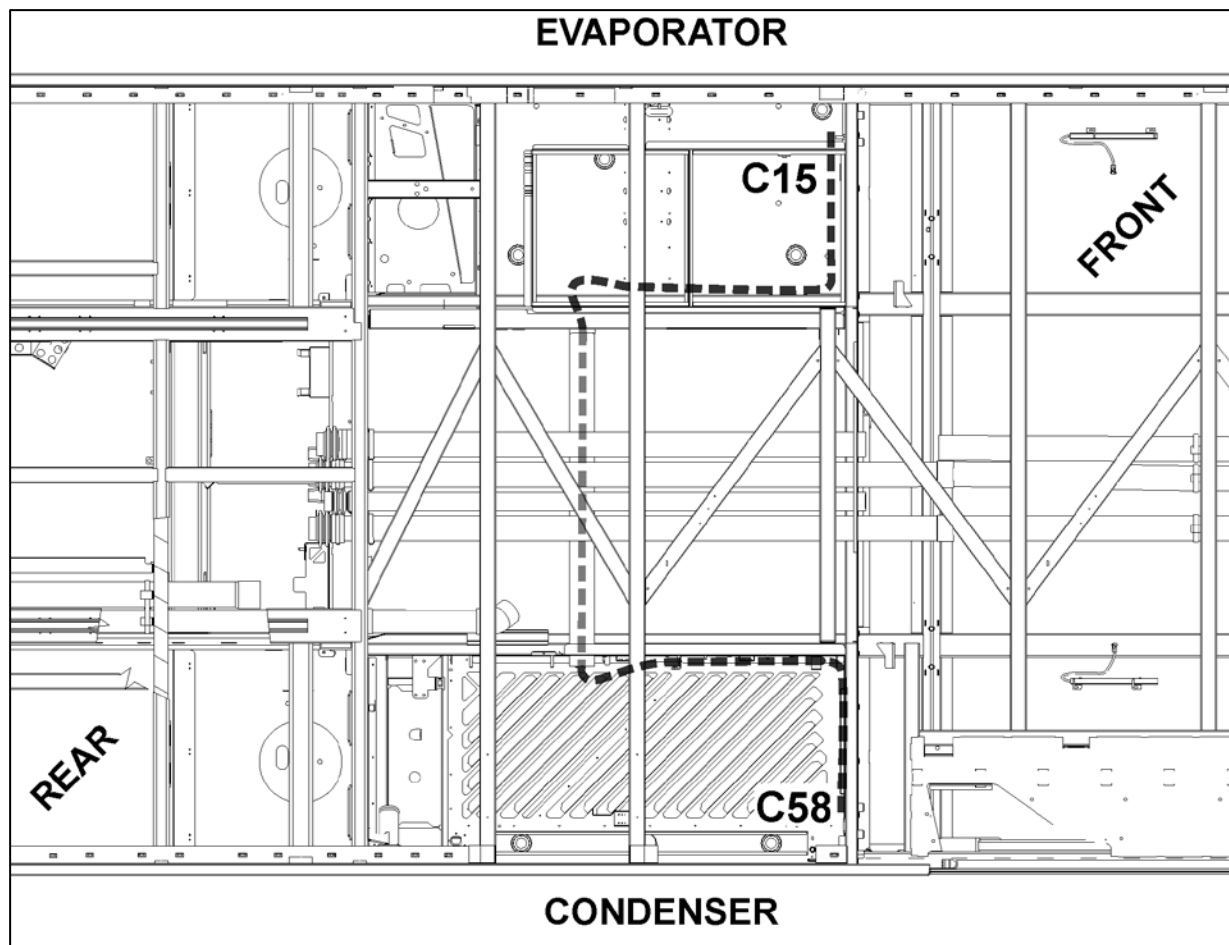
### Figure 9 : OVERVIEW

On the vehicles affected by this bulletin, remove selected wires from C15 and C58 of the HVAC system wiring, and place them in new connectors C15B and C58B. New connectors have a higher amp rating.
