GROUP CHA	MODEL 2011-2014MY Optima (QF)
NUMBER 060 (Rev 1, 2/23/2018)	DATE January 2016

TECHNICAL SERVICE BULLETIN

SUBJECT: ECU UPGRADE – STEERING LOGIC IMPROVEMENT

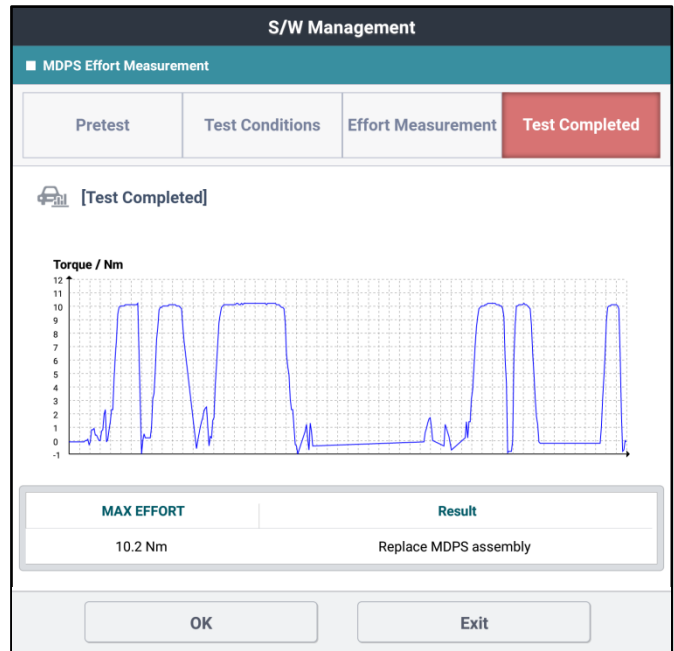
13. After performing the MDPS effort measurement test successfully, the results will be displayed along with the appropriate course of action. Select **OK** to continue.

14. Refer to the table below for the correct course of action after the 'Test Completed' screen is displayed. **NOTE: select Report to save the report for future reference.**

Item	Max. Effort	Remedy	Proceed to
Steering Effort Value	0 - 1.5 lb.ft (0 - 2.0 Nm)	No further action is required	N/A
	1.5 - 3.3 lb.ft (2.0 - 4.5 Nm)	ECU Upgrade	Page 7
	3.3 lb.ft (4.5Nm) or higher	Replace MDPS	Page 12
