SERVICE INFORMATION BULLETIN

APPLICABILITY: 2015-2017MY Legacy and Outback
 2015-2016 Impreza
 2015-2017 Crosstrek
 2016-2018MY Forester
 2016-2018MY WRX

NUMBER: 15-205-16R
DATE: 11/21/16
REVISED: 01/03/18

SUBJECT: Reprogramming File Availability to Address Operational Concerns with “Gen 2” Fujitsu-TEN (F10) Navigation and 7” Display Audio Units

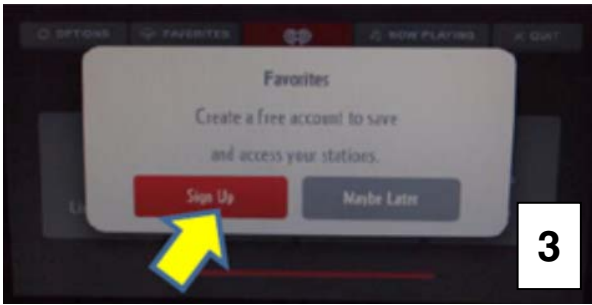
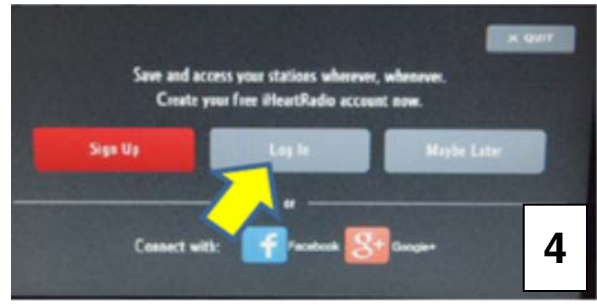
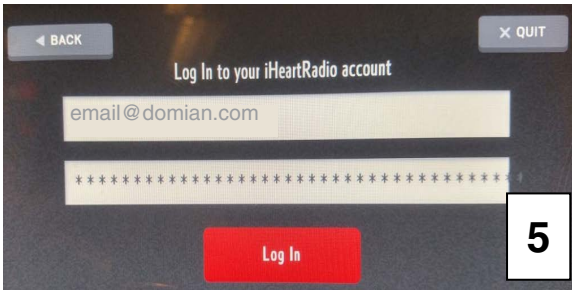
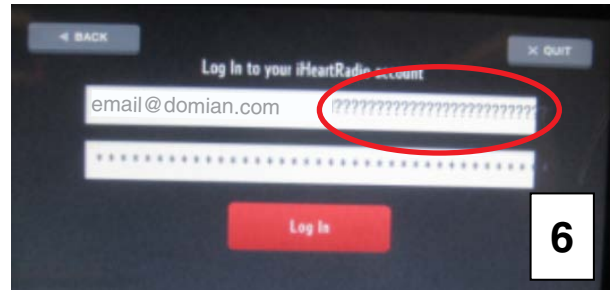
- **SXM channels higher than 256 cannot be selected using the voice command feature.**
- **Additional characters appear (in this example, question ??? marks) after entering an e-mail address and password using the software keyboard when attempting to log in to an iHeart radio account as shown in the screen shot sequence below.**
