NEW 2018 Eclipse Cross

Vehicle Technical Info

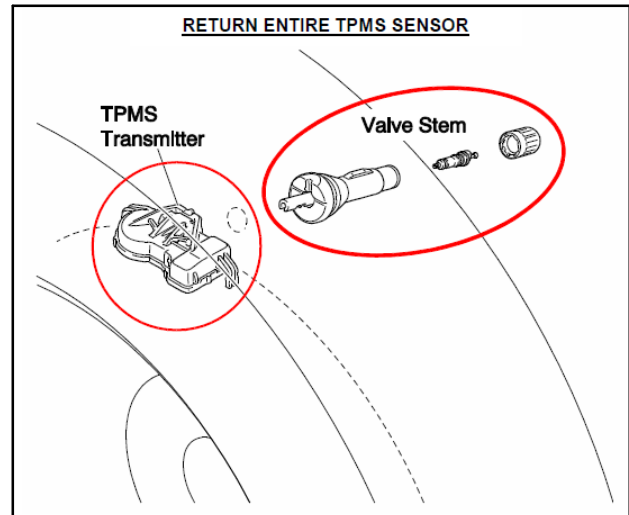
1. Return the entire TPMS transmitter and valve stem.
