Technical Service Bulletin

SUBJECT:			No: TSB-18-54-001
COMMUNICATION MALFUNCTION OF TELEMATICS CONTROL UNIT (TCU) / MITSUBISHI CONNECT			DATE: February 2018
			MODEL: 2018 Eclipse Cross
CIRCULATE TO:	<input checked="" type="checkbox"/> GENERAL MANAGER	<input checked="" type="checkbox"/> PARTS MANAGER	<input checked="" type="checkbox"/> TECHNICIAN
<input checked="" type="checkbox"/> SERVICE ADVISOR	<input checked="" type="checkbox"/> SERVICE MANAGER	<input checked="" type="checkbox"/> WARRANTY PROCESSOR	<input checked="" type="checkbox"/> SALES MANAGER

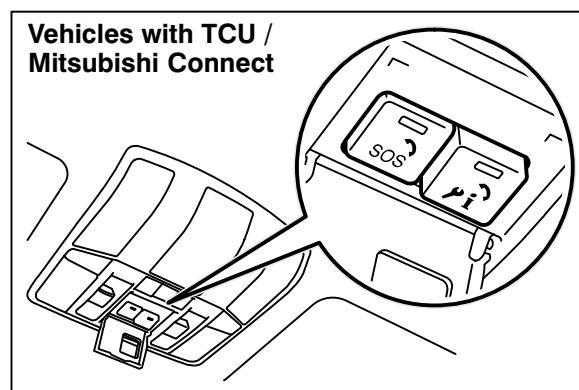
Identification of TCU-Equipped Vehicles:

To identify whether a vehicle is equipped with the Telematics Control Unit (TCU) / Mitsubishi Connect:

Look for the “SOS” and “i” buttons in the dome light area.
