## Reman CPI Nuevo Laredo - Some Reman 3126 HEUI Injectors were Shipped with an Incorrect O-ring Seal (148-2903).

(Status Updated: 20Feb2018)

CPI Number: 400017  
 Status: Open , Active  
 6 Sigma Phase: Analyze  
 Commercial Impact:  
 Initial Project Activation Date: 30Aug2017  
 Target Completion Date: 19Aug2018

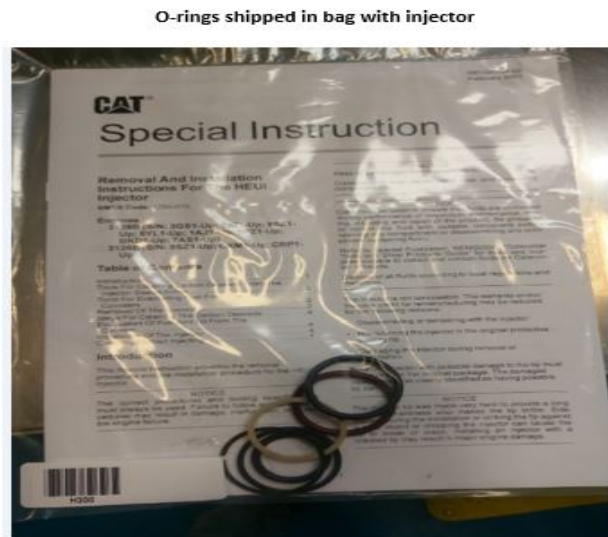
A dealer has reported that the o-ring seals, for the middle location on the injector, are too loose. From measurements, it was determined that these seals were incorrectly chosen, packaged and shipped with the injectors.

Some Reman 3126 HEUI Injectors were shipped with incorrect Case Orings (P/N 148-2903) These Orings are shipped in a separate kit with the Injector. Please use 148-2903 Oring from dealer stock to replace any incorrect Orings. Incorrect Oring is larger in internal diameter & thinner if installed will be loose on the nozzle case. Submit a part stock warranty claim for the incorrect O-ring. Please include injector serial number in the claim. Service Letter PI70680 Approved 9/25/2017. Root cause has been identified team working on Permanent corrective Action, PCA implementation end of March 2018

1: O-rings Inspection method not robust enough. When second product was introduced Failure mode & detection method were not updated.

**Repair Action:** Have field update stock with correct oring seals.
