**MODEL:** Karma Revero**Date:** October 2017**TITLE:** Dash Stitch Impression Remedy**Revised:** February 2018**PRIORITY:** On Complaint**APPLICABILITY:** MY17 and MY18 Revero**MARKET REGION:** North America**PURPOSE:** Remedy for the dash pad stitch impression on the door panel.

# Technical Service Bulletin

**TB-17-82-26**

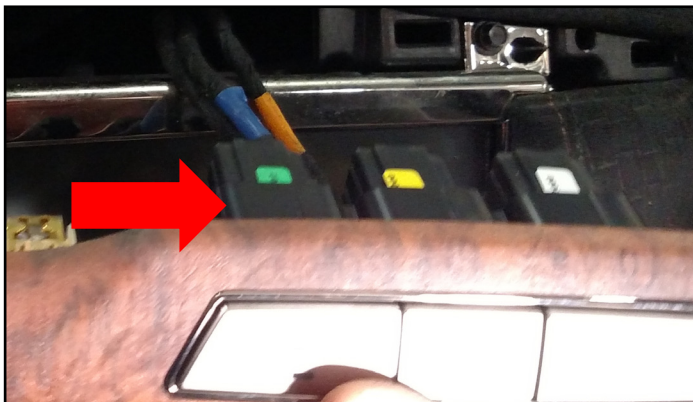
fig. 7a

The right hand side trim pad is repaired in the same manner. Remove the central console jewel, and the trim panel. These come off by pulling forward, some clips have strong tension.

Shown for example- the central trim being removed (fig 7a, 7b).

**NOTE:** Mark the connectors for correct reinstallation, if they are not already marked. These can be reinstalled to the wrong switch.(fig .7a)
