# **L9 – Jake Brake**

## **#5 Intake rocker pedestal cap screw not fully torqued**

March 26, 2018

# Navistar SAP found ESN 74273427 was running rough and had high smoke

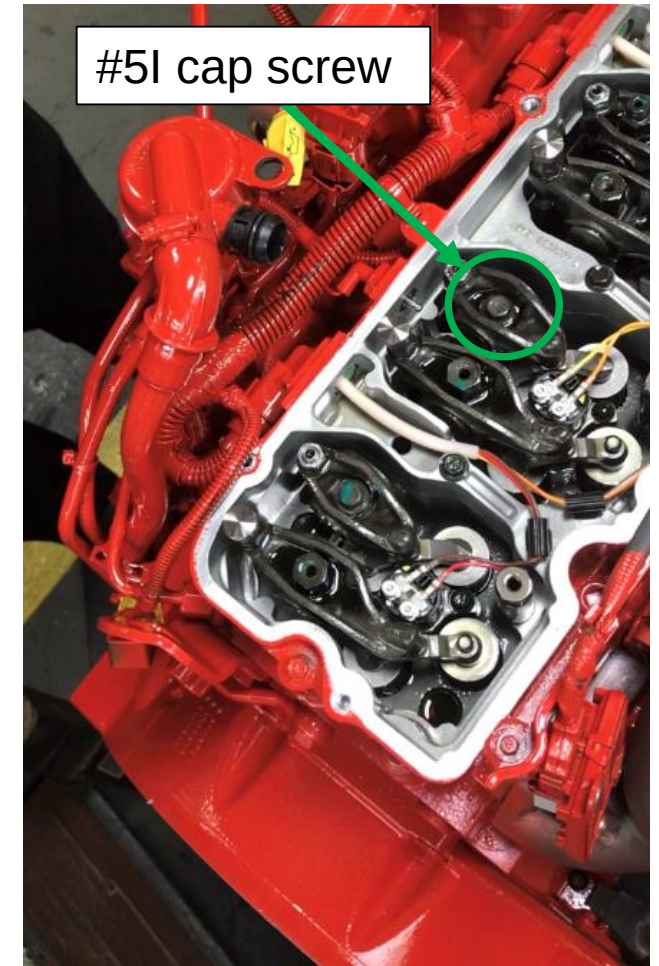
# The product was contained and a clean point was established

- Dock closure 5439 on all Jake brake engines – (3/23)
  - Verify the #5 intake rocker pedestal cap screw is torqued to 65Nm
- Reteach #5 intake on the Jake brake program – (3/23)
  - Quality verified the proper torque was applied after the change
  - ESNf **74291280**
