GROUP <b>BOD</b>	MODEL <b>2018MY Optima (JFa)</b>
	NUMBER <b>182 (Rev 3, 03/21/2018)</b>	DATE <b>January 2018</b>

## TECHNICAL SERVICE BULLETIN

**SUBJECT:** SERVICE ACTION: FLOOR CONSOLE INNER PANEL  
INSPECTION & CORRECTION/REPLACEMENT (SA328)

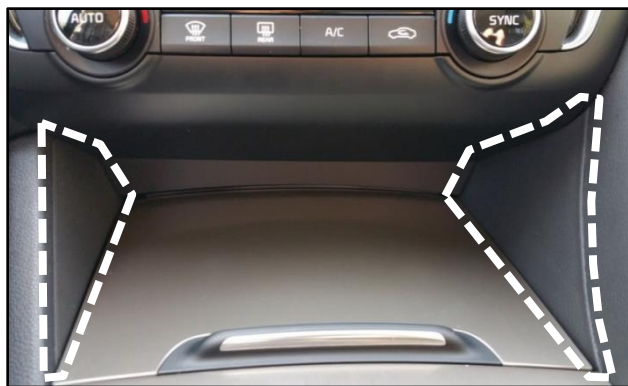
This bulletin provides the procedure to inspect and correct or replace the floor console inner side panels on some 2018MY Optima (JFa) vehicles, produced from August 1, 2017 through October 27, 2017, which may exhibit a peeling condition of the panel surface. If there is no sign of peeling at the inner side panels of the floor console, perform the solution application procedure on page 2 of this bulletin. If there is sign of peeling, replace the inner side panels by following the replacement procedure on page 3 of this bulletin. Before conducting the procedure, verify that the vehicle is included in the list of affected VINs.
