Service Campaign Bulletin SC-75

## **CUSTOMER SERVICE CAMPAIGNS 4003 AND 4004 Equator Airbag Control Unit (ACU) Reprogramming**

**Affected Models:** 2009 - 2012 Equator

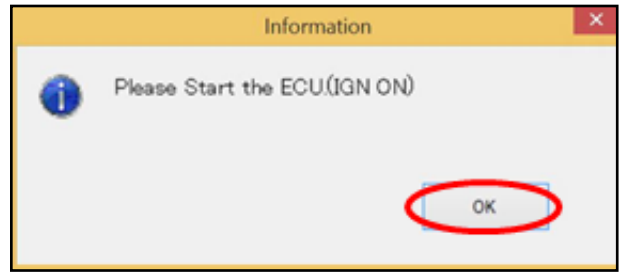
10) Turn the ignition ON but leave the engine turned off (not running). Then select **OK**.

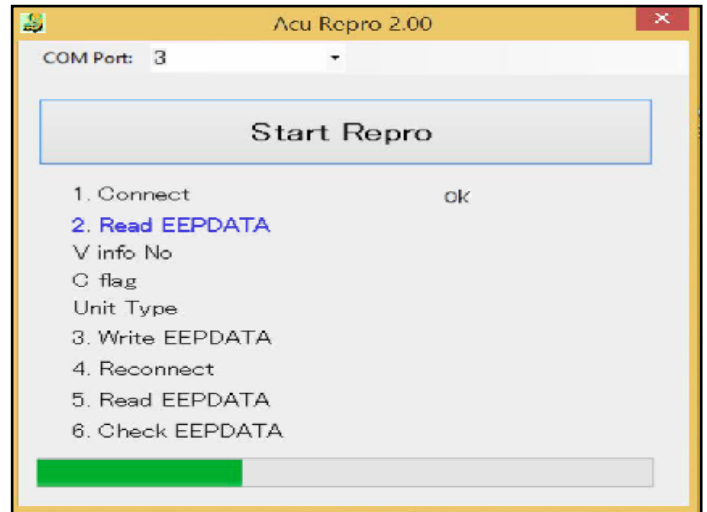
12) The software will begin programming the ACU.

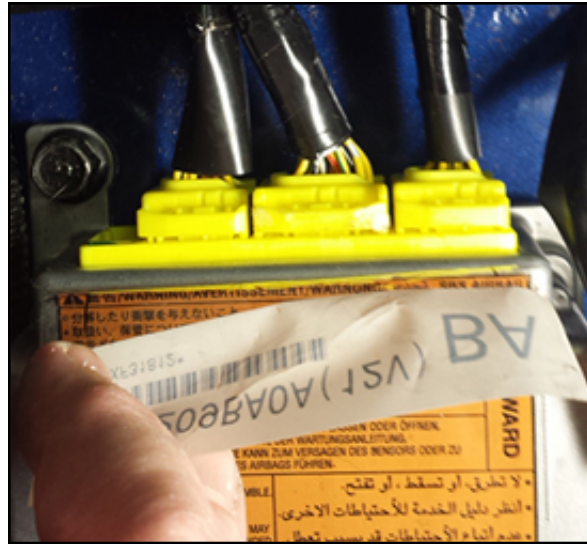
- 9) Lift the airbag control unit connector shield to access the control unit connectors.

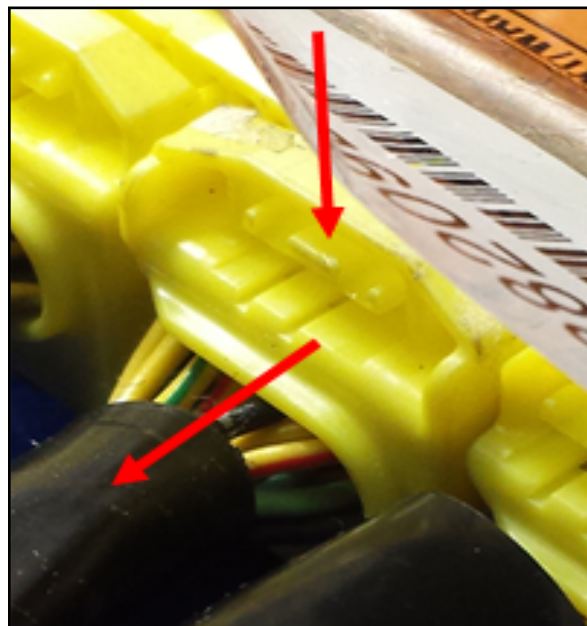
- 10) Depress the retaining lever on the center harness connector and carefully slide the connector out of the ACU.

**Pulling on the harness can damage the wires.**

**Do NOT pull on the harness.**

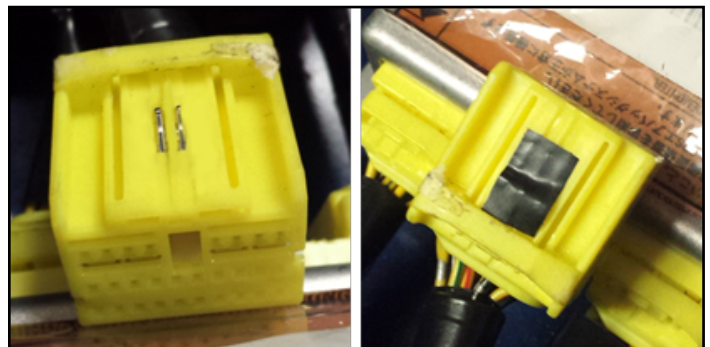
- 11) Place a small piece of electrical tape over the two contacts on the top side of the center connector and insert the connector back into the ACU.
- 12) Re-attach the battery cables to the battery, starting with the positive cable.
- 13) Continue to Section 5 below to begin programming the ACU.

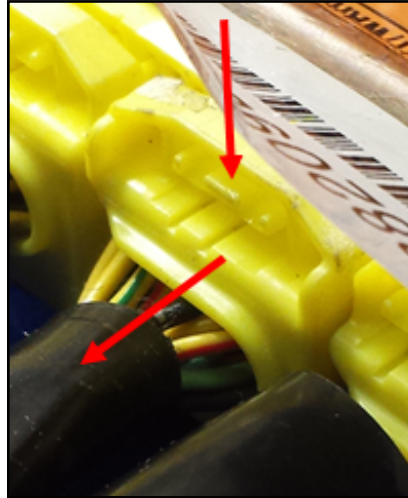
- 14) Carefully disconnect the center harness connector from the ACU.
- 15) Remove the electrical tape from the side of the airbag harness connector.

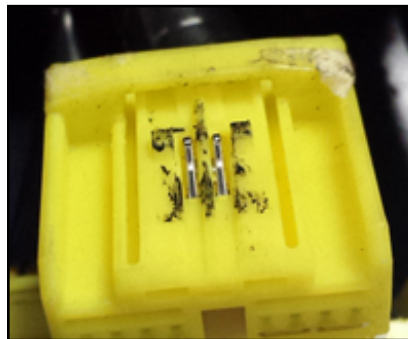
- 16) If there is any residue left from the electrical tape, carefully clean the contacts and the connector with rubbing alcohol to remove any residual glue from the contacts or connector body.
- 17) Once the connector is clean, insert it into the ACU.
