MODEL: Karma Revero**DATE:** December 2017**TITLE:** Front Door Glass Fitment Inspection and Adjustment**Revised March 2018****PRIORITY:** On Complaint**APPLICABILITY:** MY17 and MY18 Revero**MARKET REGION:** North America**PURPOSE:** Remedy for possible wind noise complaint

Technical Service Bulletin

TB-17-76-21

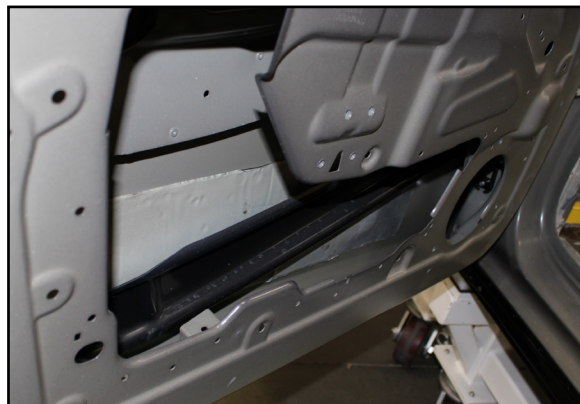
fig 5

Shown here is a door without regulator or harnesses to highlight the interior parts (fig 5).

- 4) Adjust rear regulator mount, outboard as far as required to ensure proper glass alignment (fig 4a, 4b). Maintain clearance from the side impact bar, to avoid any interference (contact) or rattles.

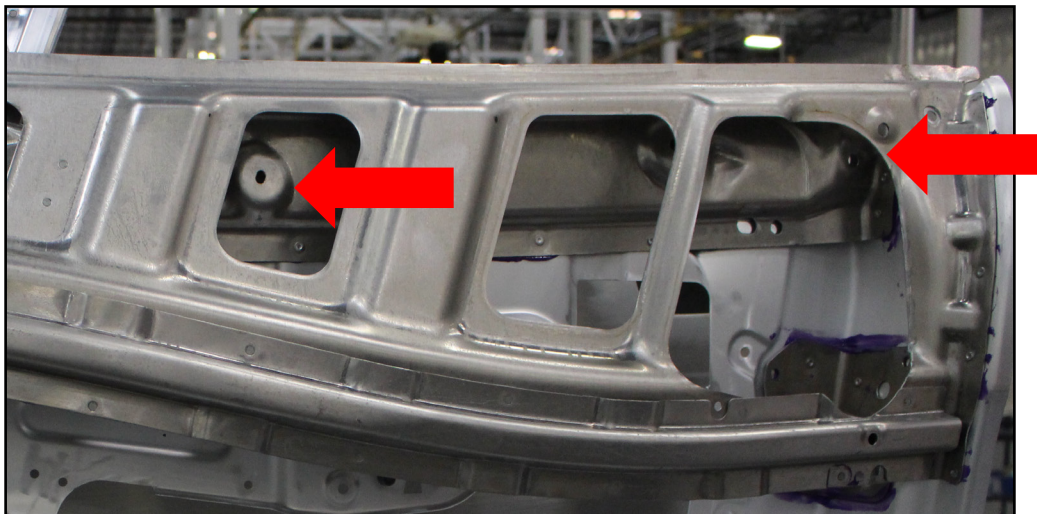
fig 6b

A bare door assembly shown here to better identify the regulator mount position (fig 6b).

- 5) Check the upper regulator mounts for shims- if required remove shims to check adjustment this may be sufficient (fig 6a). However verify that glass movement speed, up and down in the channel is not affected, as the glass may now contact the seal and create some drag. You may find one (1) or (2) shims in each position, trial should first be done removing 1 shim and checking glass to B pillar flushness and for satisfactory glass speed, if this is still unsatisfactory remove the second shim and recheck.
