## SERVICE BULLETIN

**APPLICABILITY:** 2013-14MY Legacy and Outback Models with 2.5L FB Engines  
 2011-14MY Forester Models with 2.5L FB Engines  
 2015 MY Forester (Manual Transmissions Only) with 2.5L FB Engines  
 2012-13 MY Impreza and XV Crosstrek Models with 2.0 FB Engines  
 2014-15 MY Impreza and XV Crosstrek Models (Manual Transmissions Only) with 2.0 FB Engines

**NUMBER:** 02-157-14R  
**DATE:** 08/28/14  
**REVISED:** 03/06/18

**SUBJECT:** Engine Oil Consumption

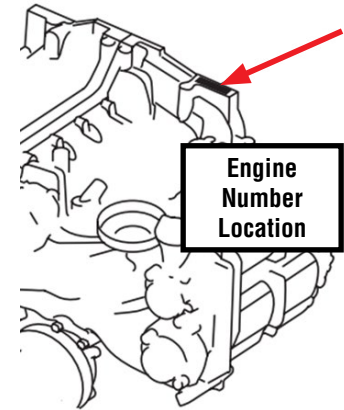
**\* NOTE:** When determining the engine number, use the **LAST 8** characters of the number stamped into the boss on top of the block adjacent to the starter and shown in the illustration. The engine number range for the FA1 assembly line is 800000 to 930025 and the FB2 range is 000000 to 652640.

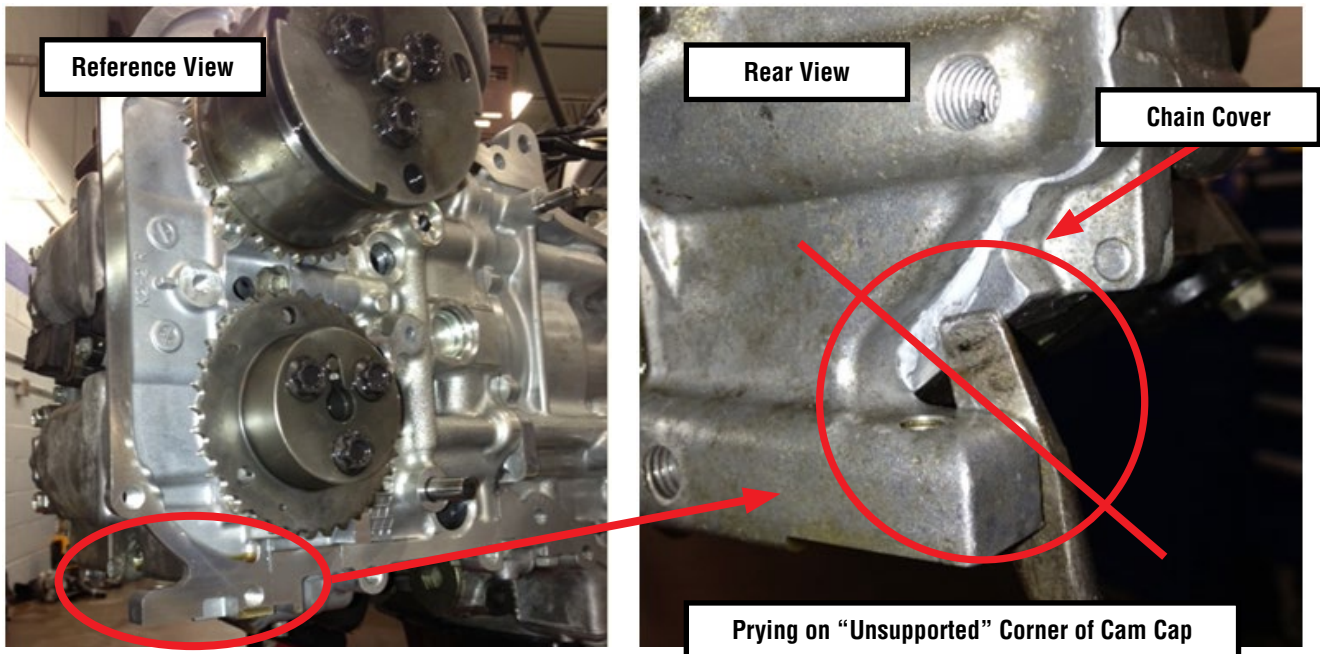
- IMPORTANT:** After all 32 bolts securing the chain cover are removed, be **EXTREMELY** careful where you pry and what you pry on to break the silicone sealant's bond. The photos below show an example of where **NOT** to pry. In this case, the cam cap became cracked requiring a complete cam carrier replacement. *Patience is the key!*
