Technical Service Bulletin

Subject: VOICE RECOGNITION SYSTEM DOES NOT RECOGNIZE "ADDRESS" OR "NEW DESTINATION" NAVIGATION VOICE COMMANDS	Bulletin No.: 09-003/18
	Last Issued: 03/05/2018

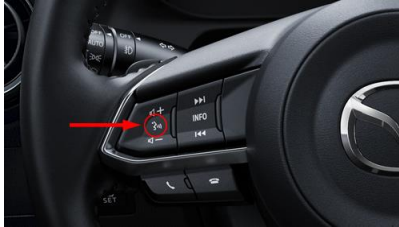
Some customers may complain that the Voice Recognition system does not recognize "Address" or "New Destination" navigation voice commands. This may be caused by faulty navigation SD card software. The SD card has been updated to eliminate this concern.

Customers having this concern should have their vehicle repaired using the following repair procedure.
