Subject: SECOND-ROW SEAT WALK-IN LEVER DOES NOT WORK	Bulletin No.: 09-009/18
	Last Issued: 03/14/2018

2016-2017 CX-9 vehicles with VINs lower than JM3TC*****142166 (produced before May 22, 2017)

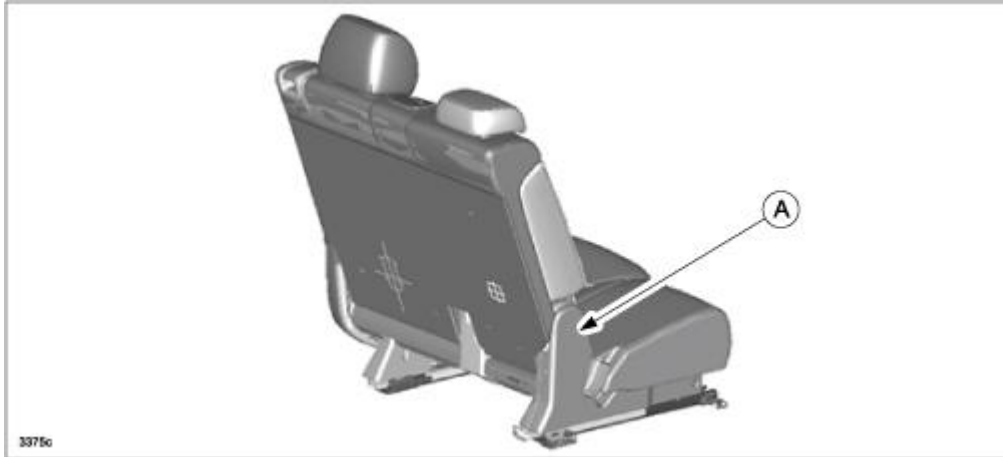
4. Remove the driver-side second-row seat and remove the side cover (A) (driver-side / rear console-side second-row seat) according to the instructions on MGSS online (SECOND-ROW SEAT SIDE COVER REMOVAL/INSTALLATION → Driver-side second-row seat → Rear console-side second-row seat side cover).

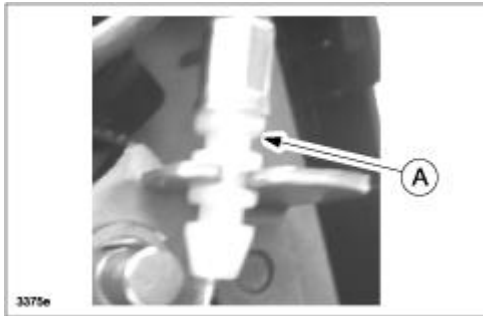
NOTE: There are three (3) installation grooves (A). Reinstall the cable in the same groove.

CAUTION: If cable is disconnected from the bracket, be sure to place it back to the original position.

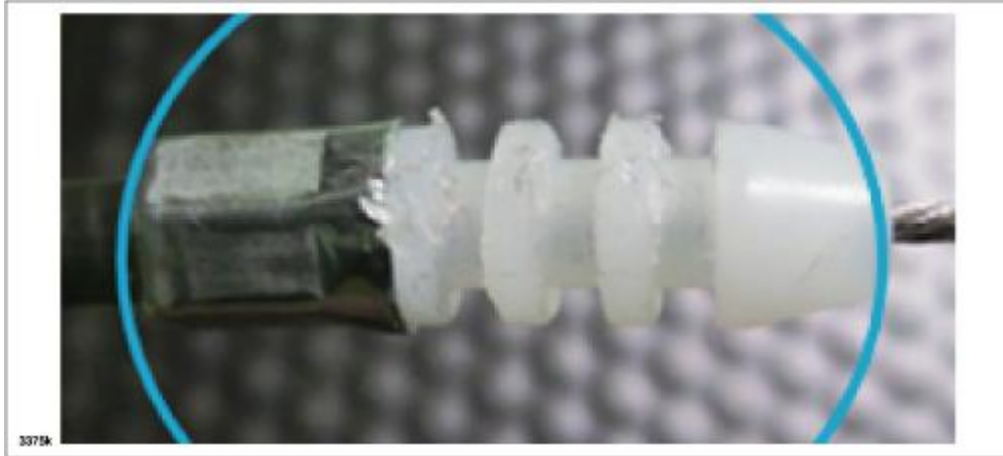
- If the cable is coming out of the bracket, check the white plastic part for damage.
- If the cable is damaged, replace it with a new one.
- If the cable is not damaged, install it back to the bracket.

NOTE: Use the same groove position to reinstall the cable.

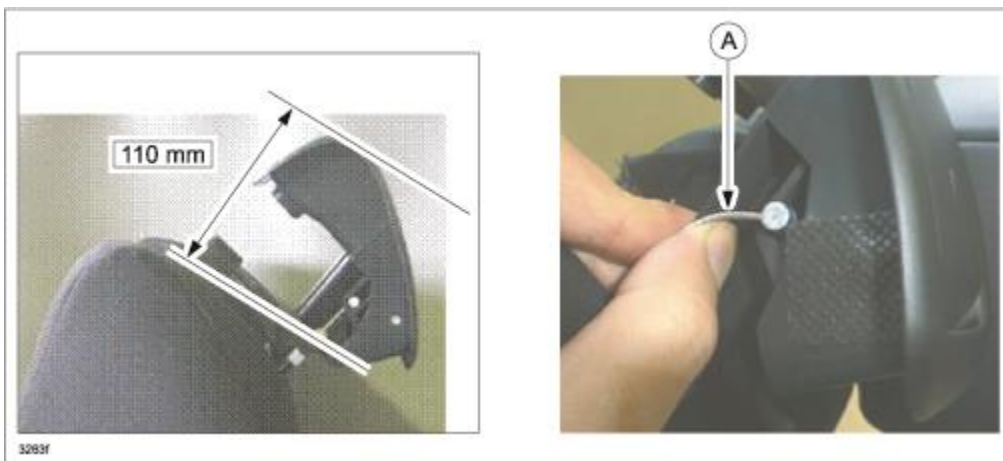
CAUTION: DO NOT lift the lever up by more than 110 mm (4.3 inches), otherwise it may be damaged.
