Technical Service Bulletin

WRINKLES ON LEATHER SEAT SURFACE OF NEW VEHICLE

Bulletin No.: 09-015/18

Last Issued: 03/22/2018

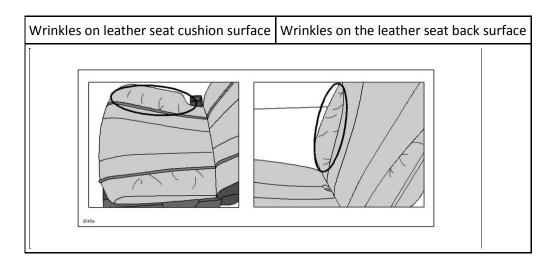
At PDI or when new vehicle is delivered, some customers may complain about wrinkles on the leather seat cushion and/or seat back surface.

Customers having this concern should have their vehicle repaired by a qualified upholstery repair specialist using the following repair procedure.

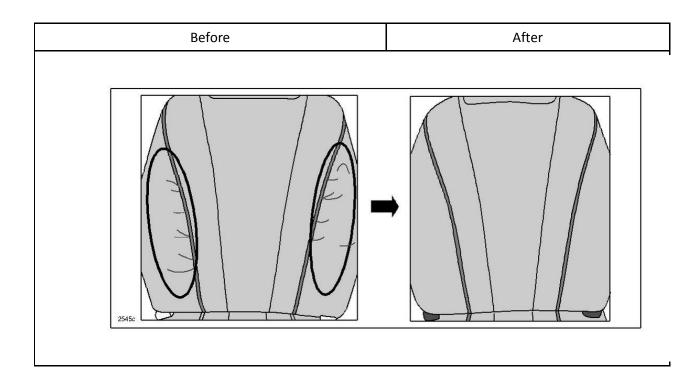
- Do NOT keep the steamer head at the same place for a long time.
- Do NOT run the steamer head without a water-soaked cloth especially over seat trim beading and seat side trim area.
- Seat damage may occur if the caution points above are nor followed as shown below.
