# Technical Service Bulletin

<b>Subject:</b> <b>ENGINE MISFIRE DURING ACCELERATION WITH CHECK ENGINE LIGHT FLASHING AND DTCs P0302:00, P0303:00 AND/OR U0401:00</b>	<b>Bulletin No.:</b> 01-010/18
	<b>Last Issued:</b> 03/29/2018

2016-2017 CX-9 vehicles with VINs lower than JM3TC\*\*\*\*\*135222 (produced before Dec. 27, 2016)

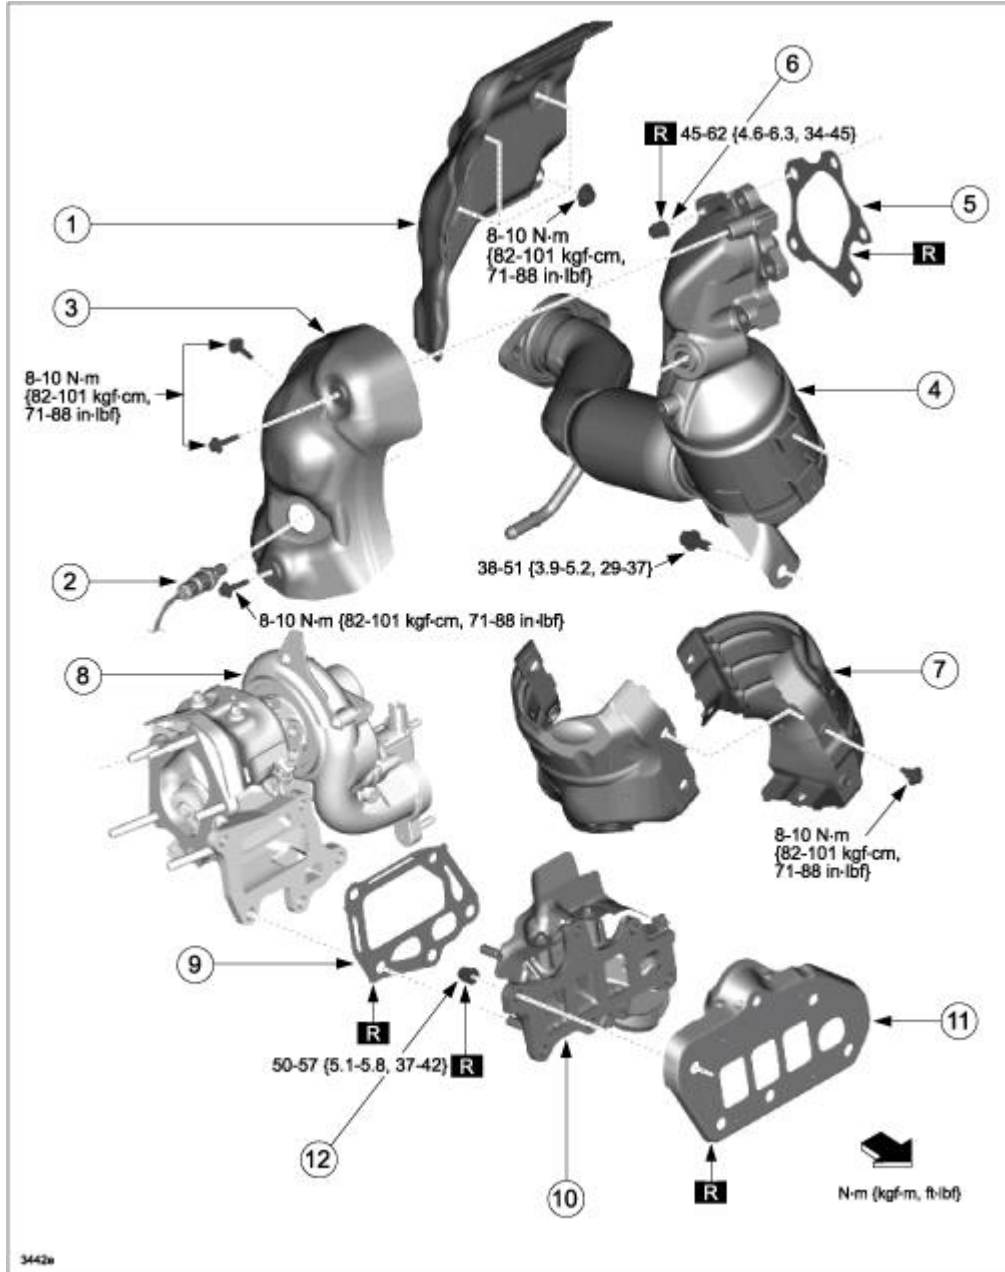
This concern may be caused if the exhaust manifold variable valve shaft (1) is out of alignment and/or the exhaust manifold variable valve housing (2) is out of shape. The exhaust manifold variable valve (3) then interferes with the housing and becomes stuck closed when the engine is hot.

1	Insulator No.1	7	Insulator No.3
2	A/F sensor	8	Turbocharger
3	Insulator No.2	9	Gasket, Turbocharger <b>(Replace)</b>
4	WU-TWC	10	Exhaust Manifold <b>(Replace)</b>
5	Gasket, WU-TWC <b>(Replace)</b>	11	Gasket, Exhaust Manifold <b>(Replace)</b>
6	Nut, WU-TWC (5) <b>(Replace)</b>	12	Nut, Exhaust Manifold (6) <b>(Replace)</b>
