January 4, 2018

Attention: Mazda Dealership Sales and Service Managers

Subject: **Dealer Rework (DRW) 09 - 2018 Mazda MX-5 Power Window Switch Concern**

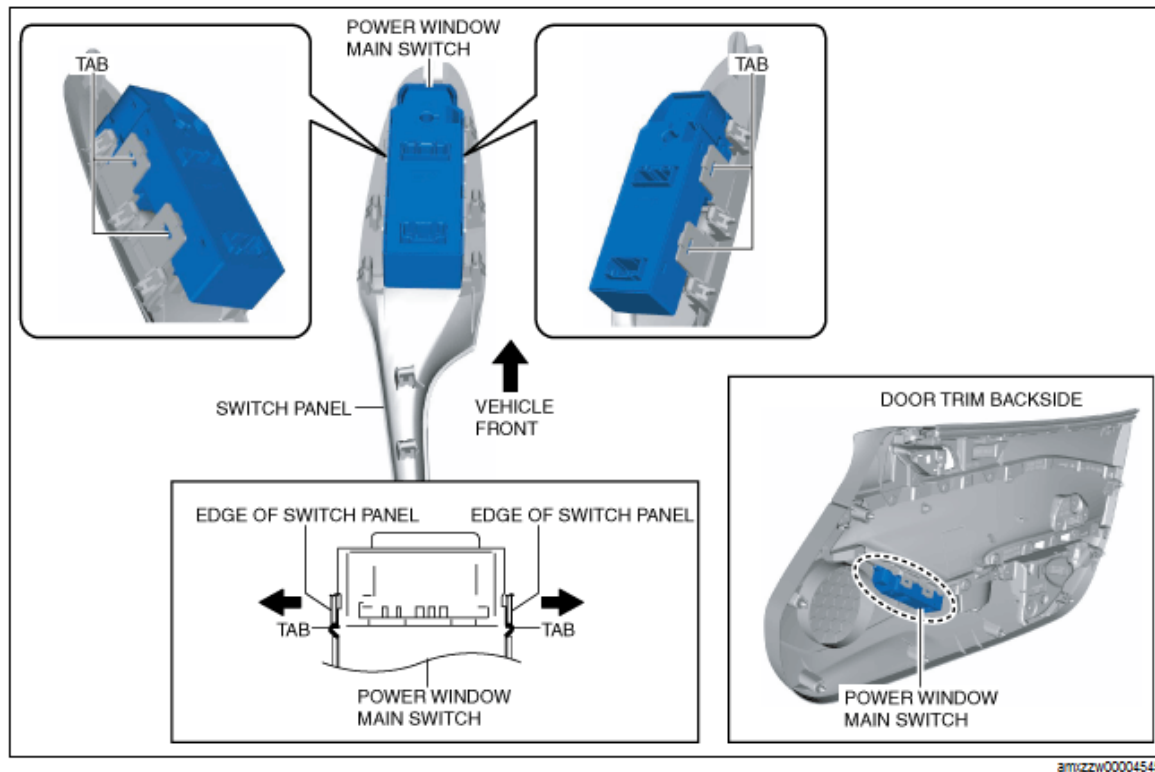
10. Disconnect the connector.
11. Move the edges of the switch panels in the directions of the arrows shown in the figure and detach the tabs from the switch panels in the order starting from the vehicle front side.

12. Remove and install the power window main switch from the switch panel. Check to re-insert to the tabs.

13. **Check again that the switch does not drop off from the original position. Refer to 【Inspection procedure】**
14. Install in the reverse order of removal.
15. The power window main switch connector is removed, perform the power window system initial setting.
