SI B01 10 14  
Warranties

## ENGINE CAMSHAFT (VANOS) ADJUSTMENT UNITS: LIMITED WARRANTY EXTENSION TO 10 YEARS WITHOUT MILEAGE LIMITATION

This Service Information bulletin supersedes SI B01 10 14 dated February 2018.

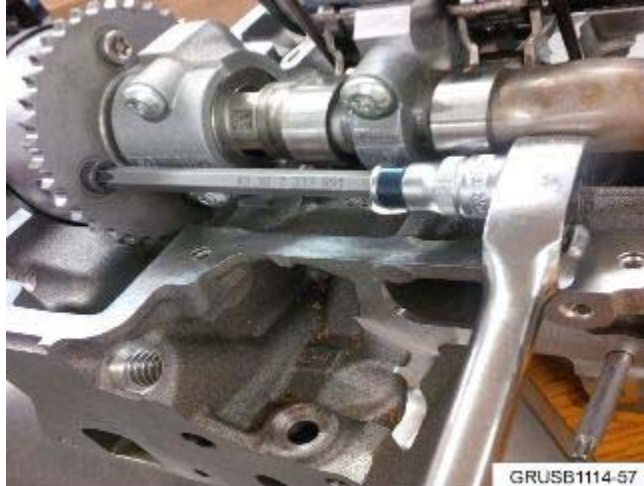
<p>GRUSB1114-57</p>	<p>5. Turn the engine by hand, using a suitable tool on the crankshaft central bolt to align one of the bolts (1), as shown in the illustration.</p> <p>Remove the bolt (1) using the required special tool (2).</p>

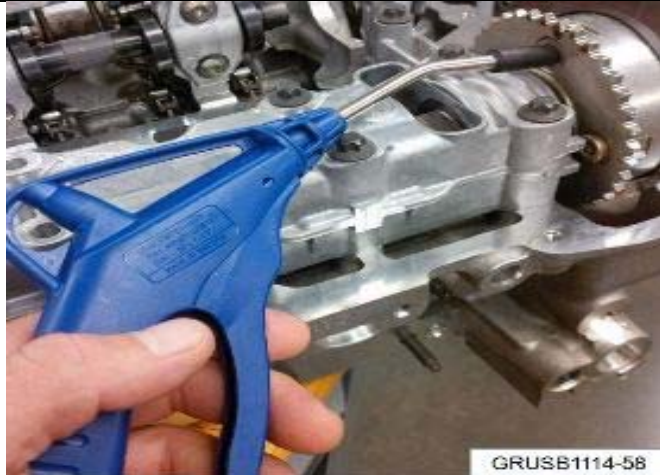
<p>GRUSB1114-58</p>	<p>6. Clean the threads on the VANOS assembly using compressed air to remove the excess oil. The torque wrench results will be more consistent when cleaning the threads for more than 3 seconds.</p> <p><b>Always wear safety glasses.</b></p>

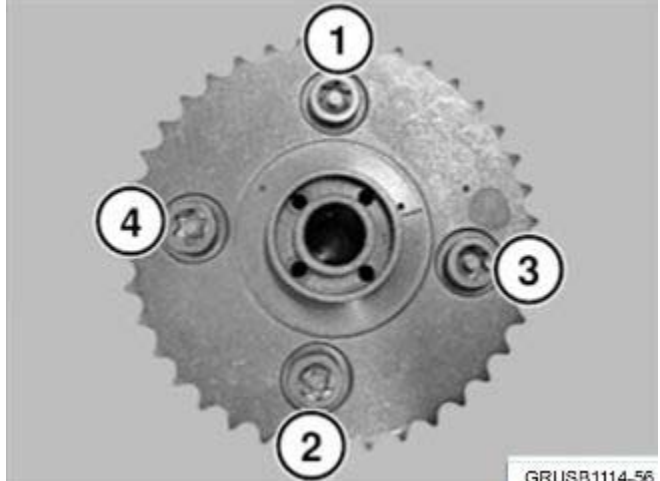
<p>GRUSB1114-66</p>	<p>10. Evaluation of bolt:</p> <p>If any of the bolts were loose or broken during this procedure, the VANOS assembly will need to be replaced. Refer to step 16.</p> <p>VANOS bolt is tight (1)</p> <p>VANOS bolt is loose (2)</p> <p>VANOS bolt heads have sheared off (3)</p> <p>Note: VANOS gear assembly removed from engine for clarity. Do not remove VANOS Gear Assembly</p>

<p>GRUSB1114-56</p>	<p>11. Replace and torque the aluminum bolts (1-4) one at a time.</p> <p><b>IMPORTANT: Never loosen more than one VANOS assembly bolt (1-4) at a time to avoid losing the sealing and alignment of gear assembly.</b></p>
