SI B11 09 16
Engine

N63, N63TU, S63 and S63TU Engines: Oil Leak from the Rear of the Engine and Transmission Bell Housing

This Service Information bulletin replaces SI B11 09 16 dated May 2016

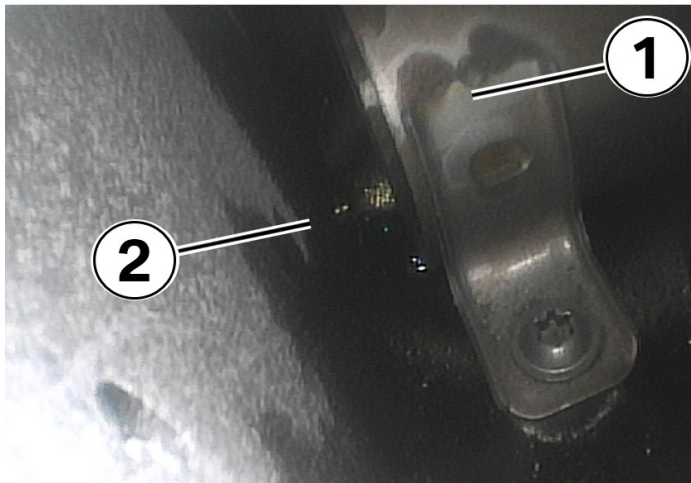
9. Continue to push the bore scope towards the vacuum reservoir (1). The engine valley drain hole is location is just to the left of the vacuum reservoir (2).

Metal vacuum reservoir shown in photo.

As the bore scope approaches the drain hole it will become more apparent.

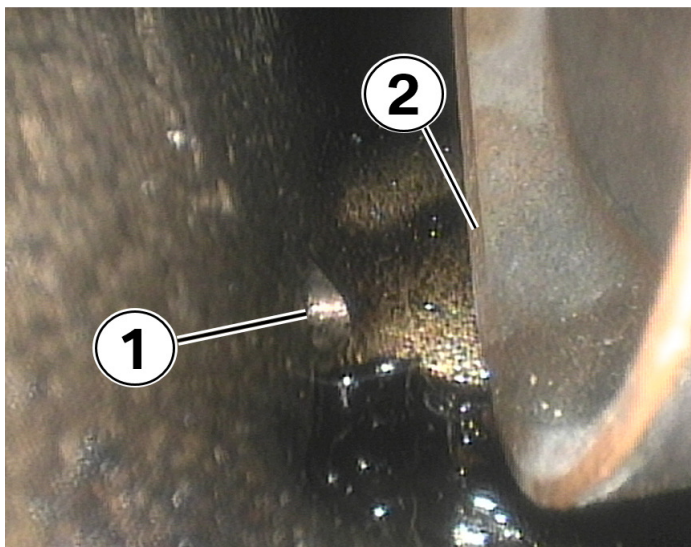
10. Inspect the surrounding area of the engine valley drain hole (1).

Engine valley drain hole (1)

Metal vacuum reservoir (2) shown.

11. If engine oil is found in this area then the root cause of the engine oil leak resides in the components on top of the engine i.e. turbocharger oil lines, turbo charger, etc. Further basic diagnosis will be needed to find the root cause this engine oil leak. Do not remove the transmission from the vehicle.

If no engine oil residue is found at the engine valley drain hole then the root cause of the engine oil leak will be inside the transmission bellhousing. The most likely cause will be a leaking engine oil galley plug located behind the engine cover, rear and or the crankshaft rear seal. Continue to step 12.

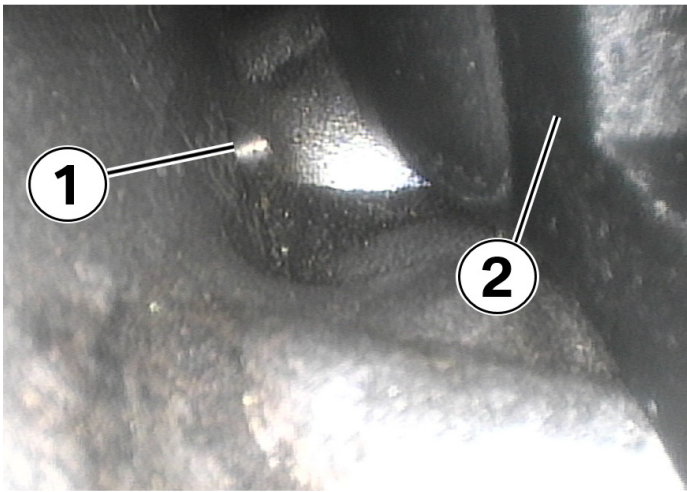
Once the bore scope has gone under the plastic reservoir tab then the engine valley drain hole (1) and surrounding area can be clearly inspected.

The dark material at the bottom of the photo is dust and dirt. This material appears to be reflective but it is dry.
