SI M54 04 17
Special Roofs

SERVICE ACTION: REWORKING THE SOFT TOP BOW BEARING

This Service Information bulletin supersedes SI M54 04 17 dated February 2018.

F57 (Cooper, Cooper S, JCW Convertible)			
---	--	--	--

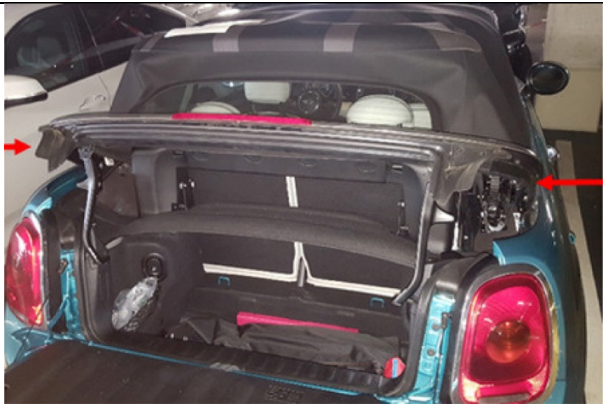
<p>1. Before beginning the rework, note the gap between the front and rear trim for reference. When the rework is complete, make sure this distance is maintained. Adjust trim position if necessary.</p>

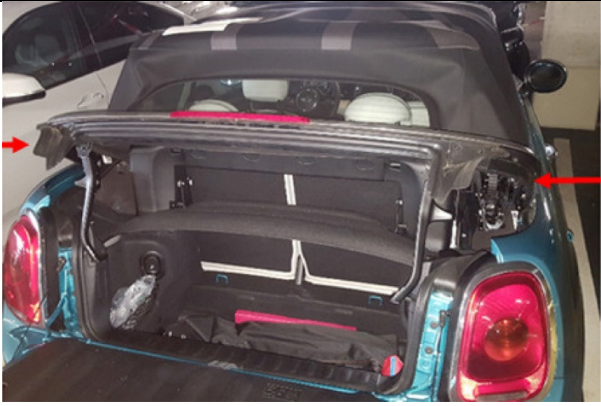
Note: Be certain the head of the shoulder bolt nor the bearing element protrude from the bearing support.</p>
