# Technical Service Bulletin

MAZDA SERVICE PROGRAM (MSP49) - CREAKING / SQUEAKING NOISE FROM RIGHT REAR SUSPENSION Last Issued: 02/14/2018

Bulletin No.: 02-004/18	Last Issued: 02/14/2018

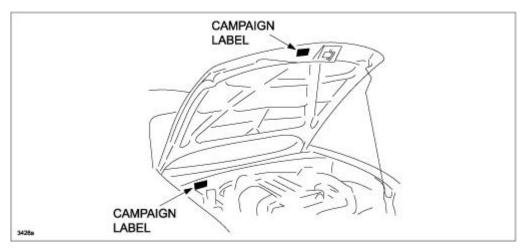
Refer to eMDCS System - Warranty Vehicle Inquiry Results table below.

NOTE: Verify the campaign number as the vehicle may have multiple labels.
