SI B52 01 18
Seats

March 2018
Technical Service

EXPOSED FOAM IS VISIBLE UNDER THE FRONT SEAT

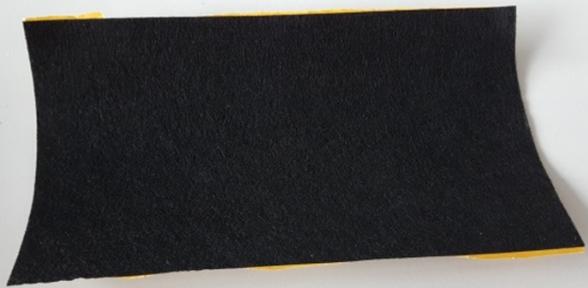
Backrest foam, in the vicinity of the backrest adjustment lever, is deformed.

Replace backrest foam and reinforce with felt tape to prevent reoccurrence.

<p>Introduction or Preparatory Items:</p> <p>Cut a piece of adhesive-backed felt – 180 mm x 100 mm</p>
