GROUP <b>BOD</b>	MODEL <b>2018MY Stinger (CK)</b>
	NUMBER <b>184</b>	DATE <b>April 2018</b>
<b>TECHNICAL SERVICE BULLETIN</b>		
<b>SUBJECT: SERVICE ACTION: REAR HATCH RATTLE REPAIR BY STRIKER ADJUSTMENT (SA347)</b>

This bulletin provides the procedure to inspect and/or adjust the rear hatch striker on some 2018MY Stinger (CK) vehicles, produced from September 21, 2017 through December 18, 2017, which may exhibit a rattle noise while driving, especially over bumps. Follow the procedure outlined in this bulletin to adjust the rear hatch striker\*. Before conducting the procedure, verify that the vehicle is included in the list of affected VINs.

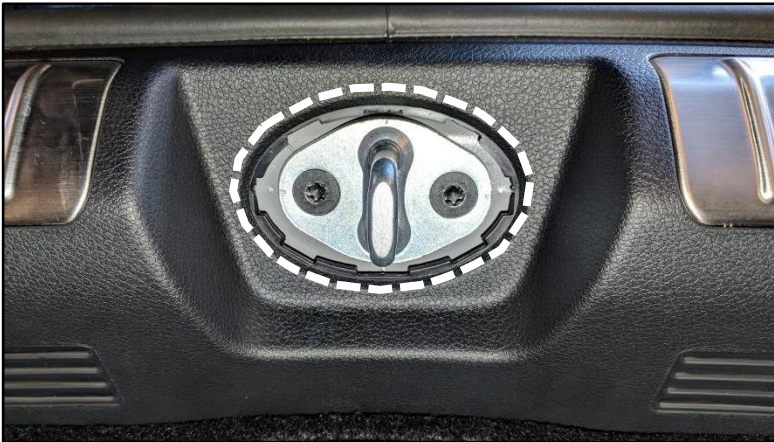
\*Note that this Service Action covers ONLY vehicles outside of SA322A. All VINs in this Service Action (SA347) already had the guide bumper pads and washers installed and overslam bumpers adjusted.
