# Technical Service Bulletin

<b>Subject:</b> <b>ENGINE MISFIRE DURING ACCELERATION WITH CHECK ENGINE LIGHT FLASHING AND DTCs P0302:00, P0303:00 AND/OR U0401:00</b>	<b>Bulletin No.:</b> 01-010/18
	<b>Last Issued:</b> 04/27/2018

2016-2017 CX-9 vehicles with VINs lower than JM3TC\*\*\*\*\*135222 (produced before Dec. 27, 2016)

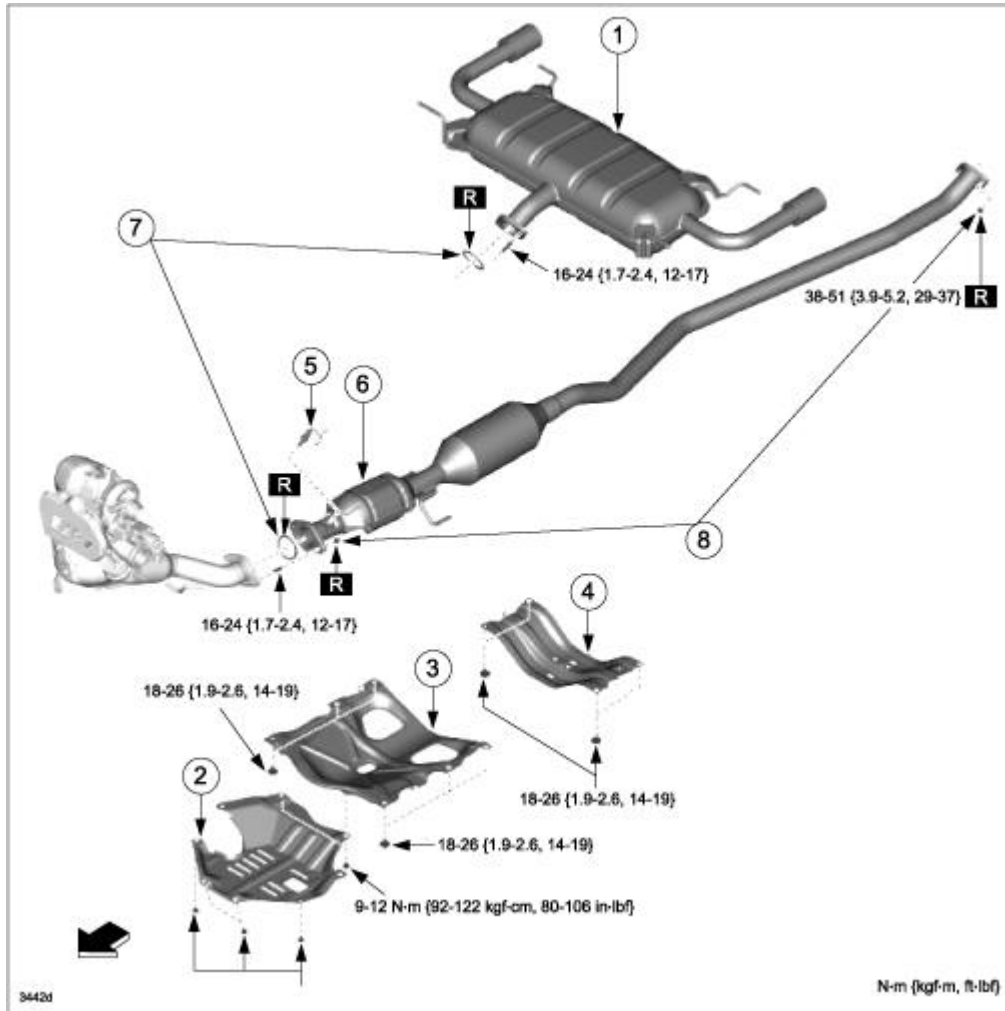
Part Location

1	Main silencer	5	HO2S
2	Plate	6	TWC
3	Brace bar	7	Gasket (2) <b>(Replace)</b>
4	Tunnel Member	8	Nut (4) <b>(Replace)</b>

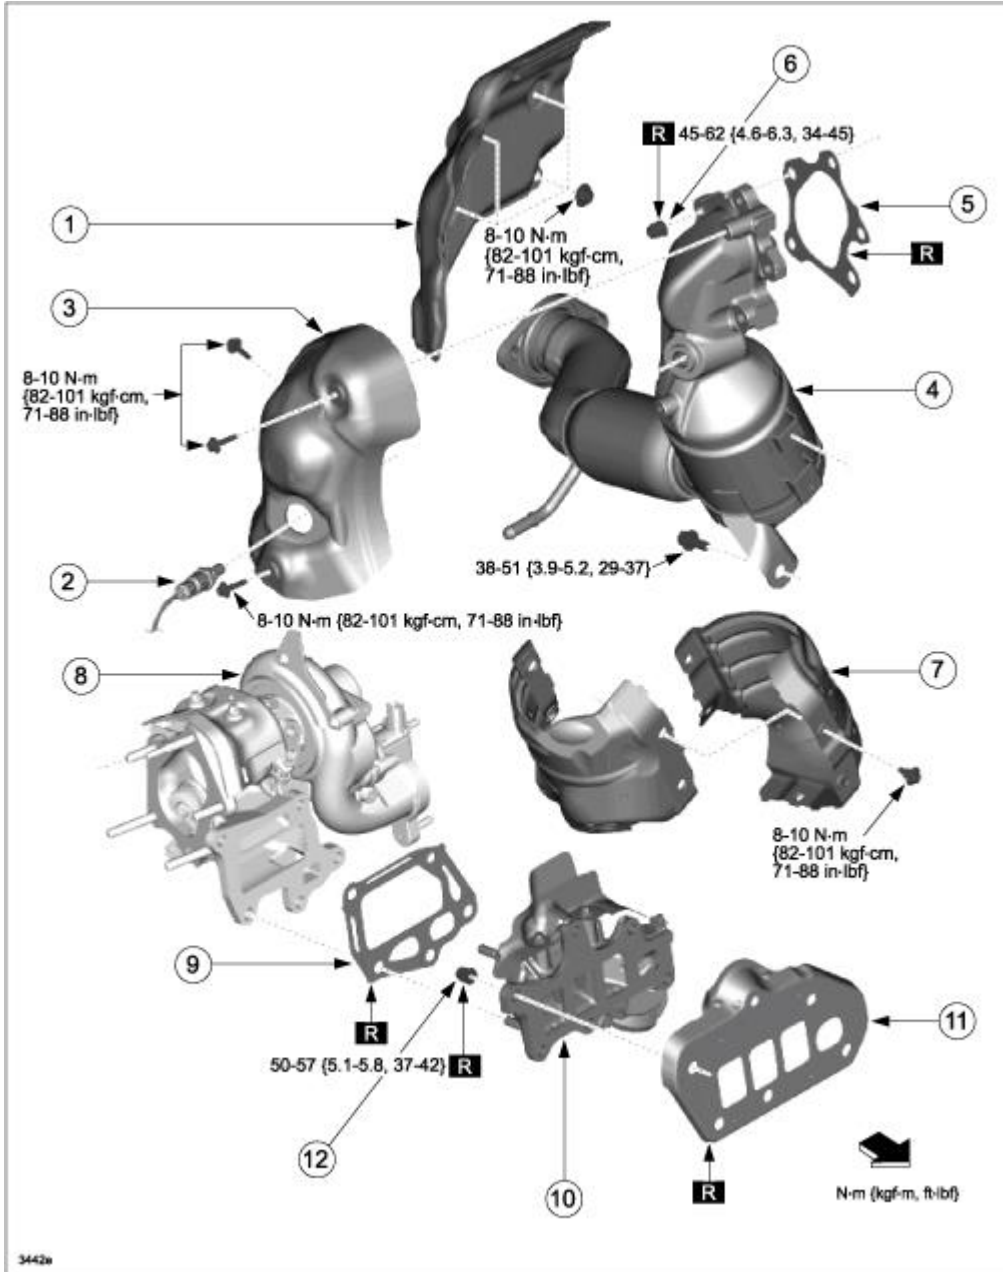
3442a

1	Insulator No.1	7	Insulator No.3
2	A/F sensor	8	Turbocharger
3	Insulator No.2	9	Gasket, Turbocharger <b>(Replace)</b>
4	WU-TWC	10	Exhaust Manifold <b>(Replace)</b>
5	Gasket, WU-TWC <b>(Replace)</b>	11	Gasket, Exhaust Manifold <b>(Replace)</b>
6	Nut, WU-TWC (5) <b>(Replace)</b>	12	Nut, Exhaust Manifold (6) <b>(Replace)</b>
