Technical Service Bulletin

DRIVER AND/OR PASSENGER SEAT WARMER(S) INOPERATIVE - (CLOTH SEATS ONLY)

Bulletin No.: 09-017/18

2013-2016 CX-5 vehicles equipped with cloth seats

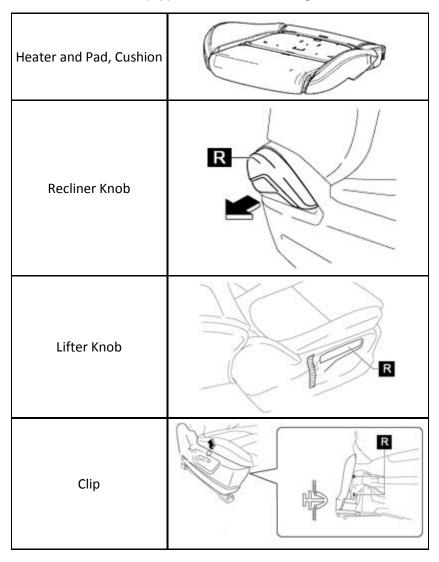
- A new seat cushion pad is available with a repositioned internal heater mat wire to prevent contact with the reinforcement rod.
- 2016 CX-5: There is no modified seat cushion available for the front passenger side seat, only the driver's side seat cushion is available.
- 3. Verify the repair.

NOTE:

- Use GEPC with VIN to look up the latest part number(s).
- For vehicles equipped with leather seats, go to TSB 09-015/17.
