Service Bulletin

Bulletin No.: 16-NA-370

Subject: Sunroof Rattle, Creak, Tick and/or Double Click Noise During Operation

Brand:	Model:	Model Year:		VIN:		Engine:	Transmission:
		from	to	from	to		
Cadillac	CT6	2016	2017			All	All

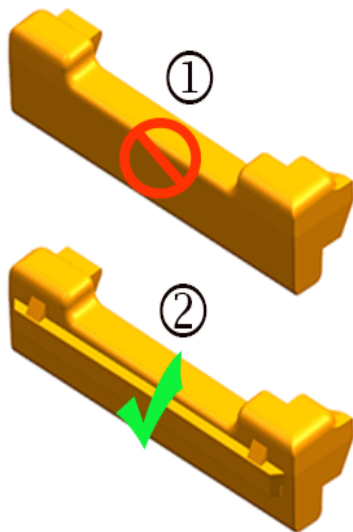
4622225

Note: To improve performance, a more robust second design of the sunroof inner middle seal has been implemented. The first graphic above shows the difference between the first (1) and second (2) design level.

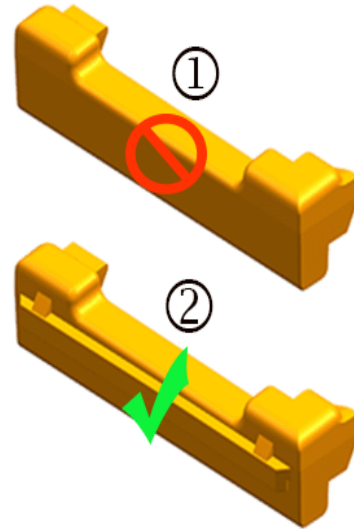
4622225

Note: To improve performance, a more robust second design of the sunroof inner middle seal has been implemented. The first graphic above shows the difference between the first (1) and second (2) design level.
