Service Bulletin

Subject: Aftermarket Installed Service, Tool or Utility Box Sagging, Mis-aligned, Forward Box Mount Bracket Fractured on Trucks Equipped with Aftermarket Bodies

Models: 2011-2018 Chevrolet Silverado 2500HD-3500HD Series
2011-2018 GMC Sierra 2500HD-3500HD Series
Incomplete Vehicles Equipped with RPO ZW9 Box Delete and Aftermarket Bodies

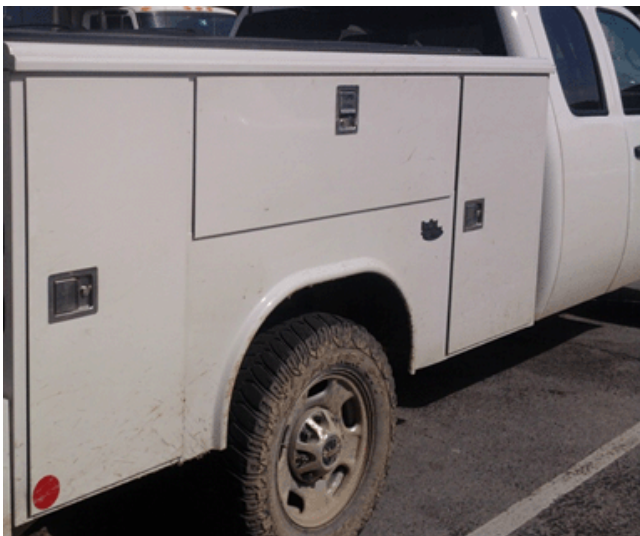
Some customers may comment that the utility box is sagging, not level or misaligned. Upon inspection, the technician may find cracked or fracture front bed mount bracket(s).
