# SERVICE BULLETIN

Classification: EC16-026b	Reference: NTB16-086b	Date: April 19, 2018
------------------------------	--------------------------	-------------------------

## 2013-2014 SENTRA; ENGINE TURNS OFF OR HESITATES WHEN ACCELERATING FROM A STOP DURING HOT AMBIENT TEMPERATURES (100° F OR MORE)

**APPLIED VEHICLES:** 2013-2014 Sentra (B17)

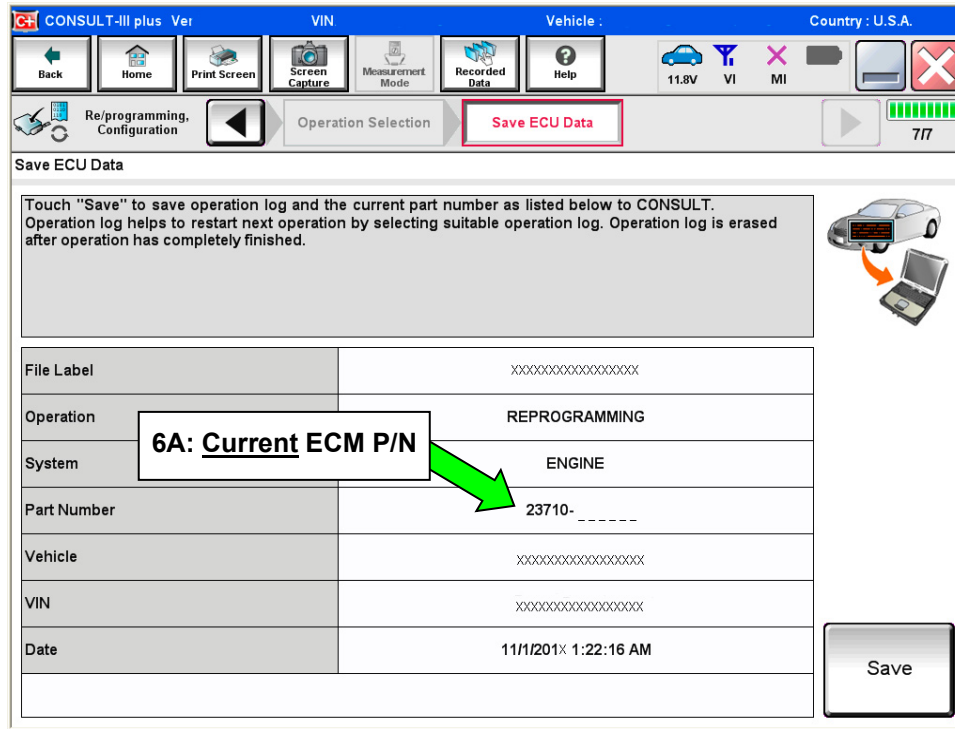
Figure 2

6. When you get to the screen shown in Figure 2, confirm this bulletin applies as follows.

A. Find the ECM **Part Number** and write it on the repair order.

**NOTE:** This is the current ECM Part Number (P/N).

B. Compare the P/N you wrote down to the numbers in the **Current ECM Part Number** column in **Table A** on the next page.

- If there is a match, continue with the reprogramming procedure.
- If there is not a match, reprogramming is not needed.

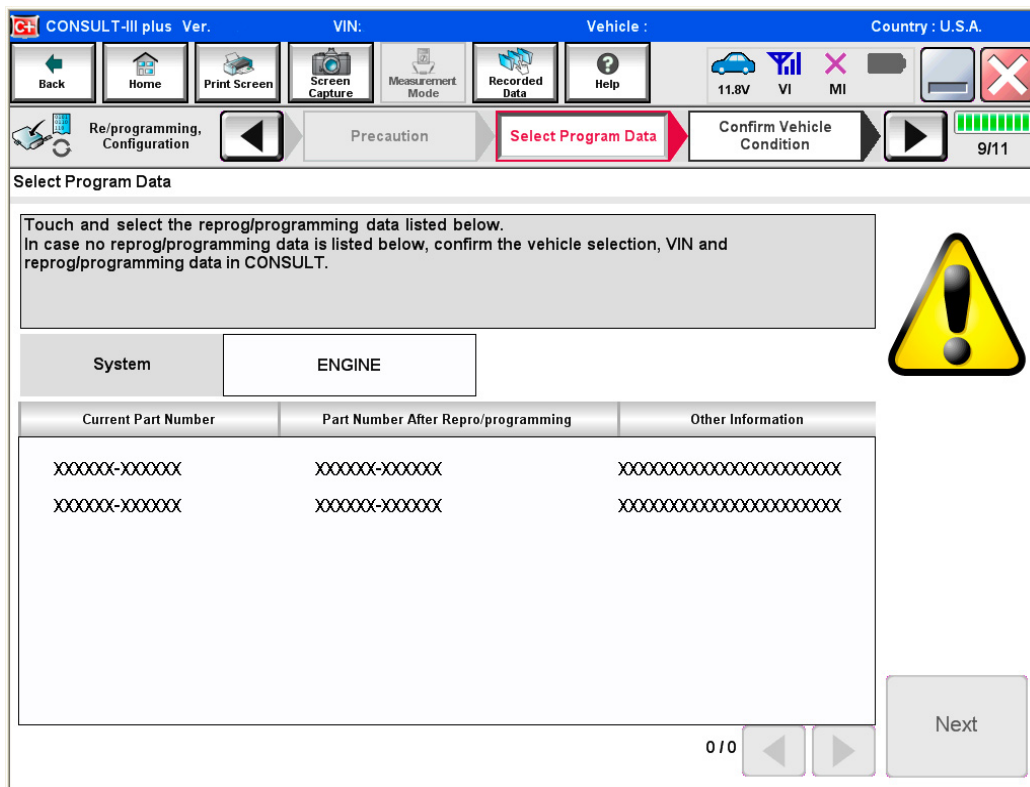
- In some cases, more than one new P/N for reprogramming is available.
  - If there is more than one new P/N, the screen in Figure 3 displays.
  - Select and use the reprogramming option that **does not** have the message “Caution! Use ONLY with NTBXX-XXX”.
- If you get this screen and it is blank (no reprogramming listed), it means there is no reprogramming available for this vehicle.

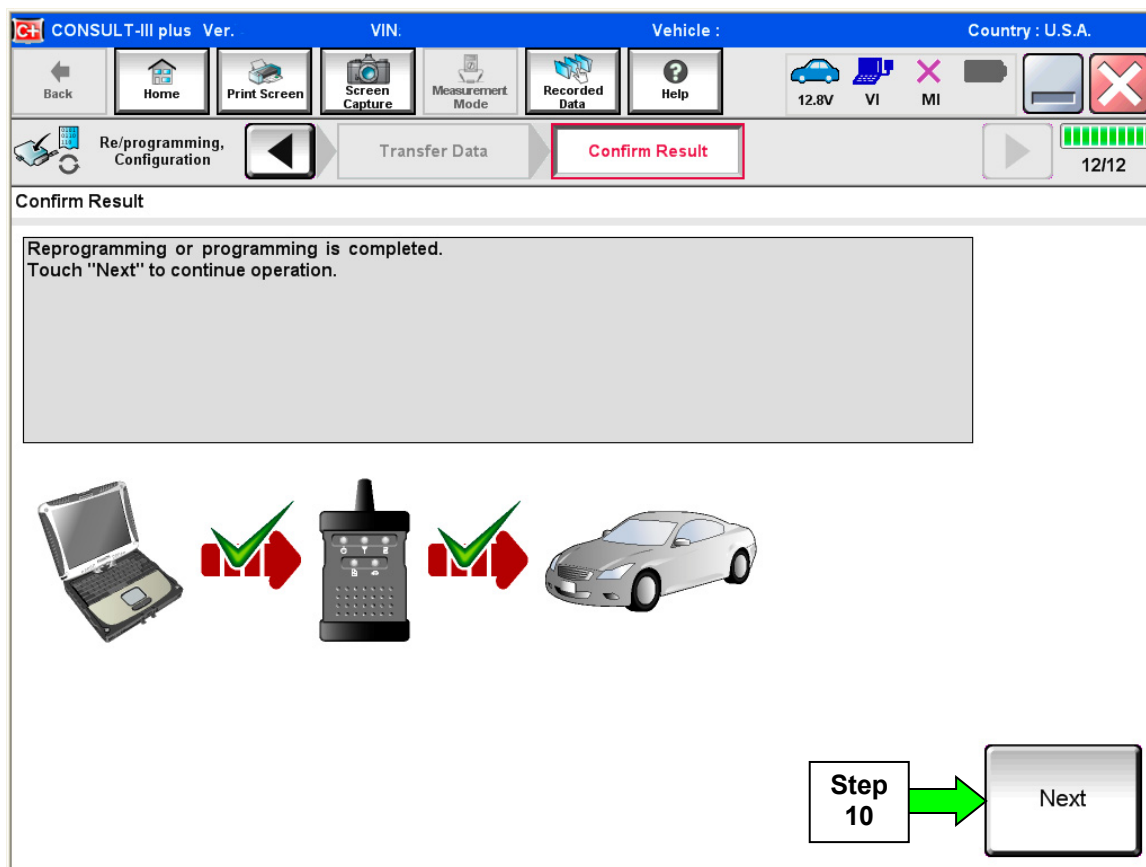
8. When the screen in Figure 4 displays, reprogramming is complete.

**NOTE:** If the screen in Figure 4 does not display (which indicates that reprogramming did not complete), refer to the information on the next page 8.

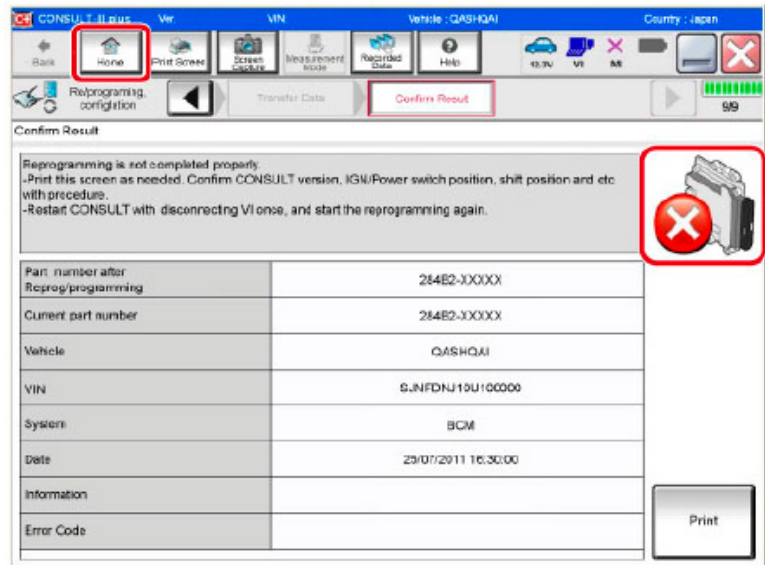
Figure 6

If reprogramming does not complete and the “X” icon displays as shown in Figure 6:

- Check battery voltage (12.0 – 15.5 V).
- CONSULT A/C adapter is plugged in.
- Ignition is ON, engine OFF.
- Transmission is in Park.
- All C-III plus / VI cables are securely connected.
- All C-III plus updates are installed.
- **Select Home, and restart the reprogram procedure from the beginning.**

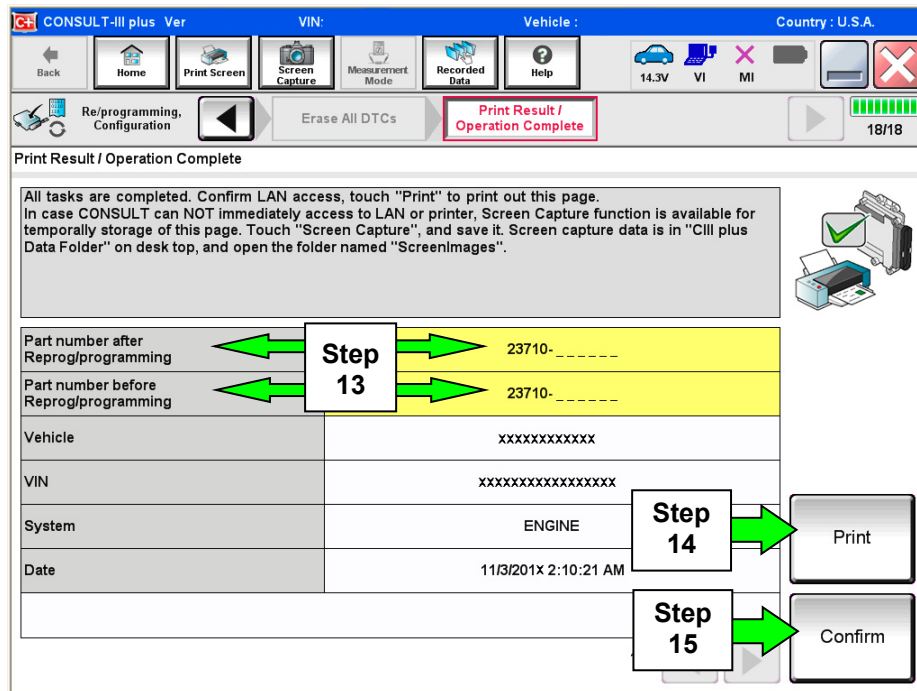
12. When the entire reprogramming process is complete, the screen in Figure 7 will display.

13. Verify the before and after part numbers are different.

14. Print a copy of this screen (Figure 7) and attach it to the repair order for warranty documentation.
