Body ATU
January 2018

Work specific to Cabriolet, A5/B9 Cabriolet

Q7/A4 – power-operated rear lid

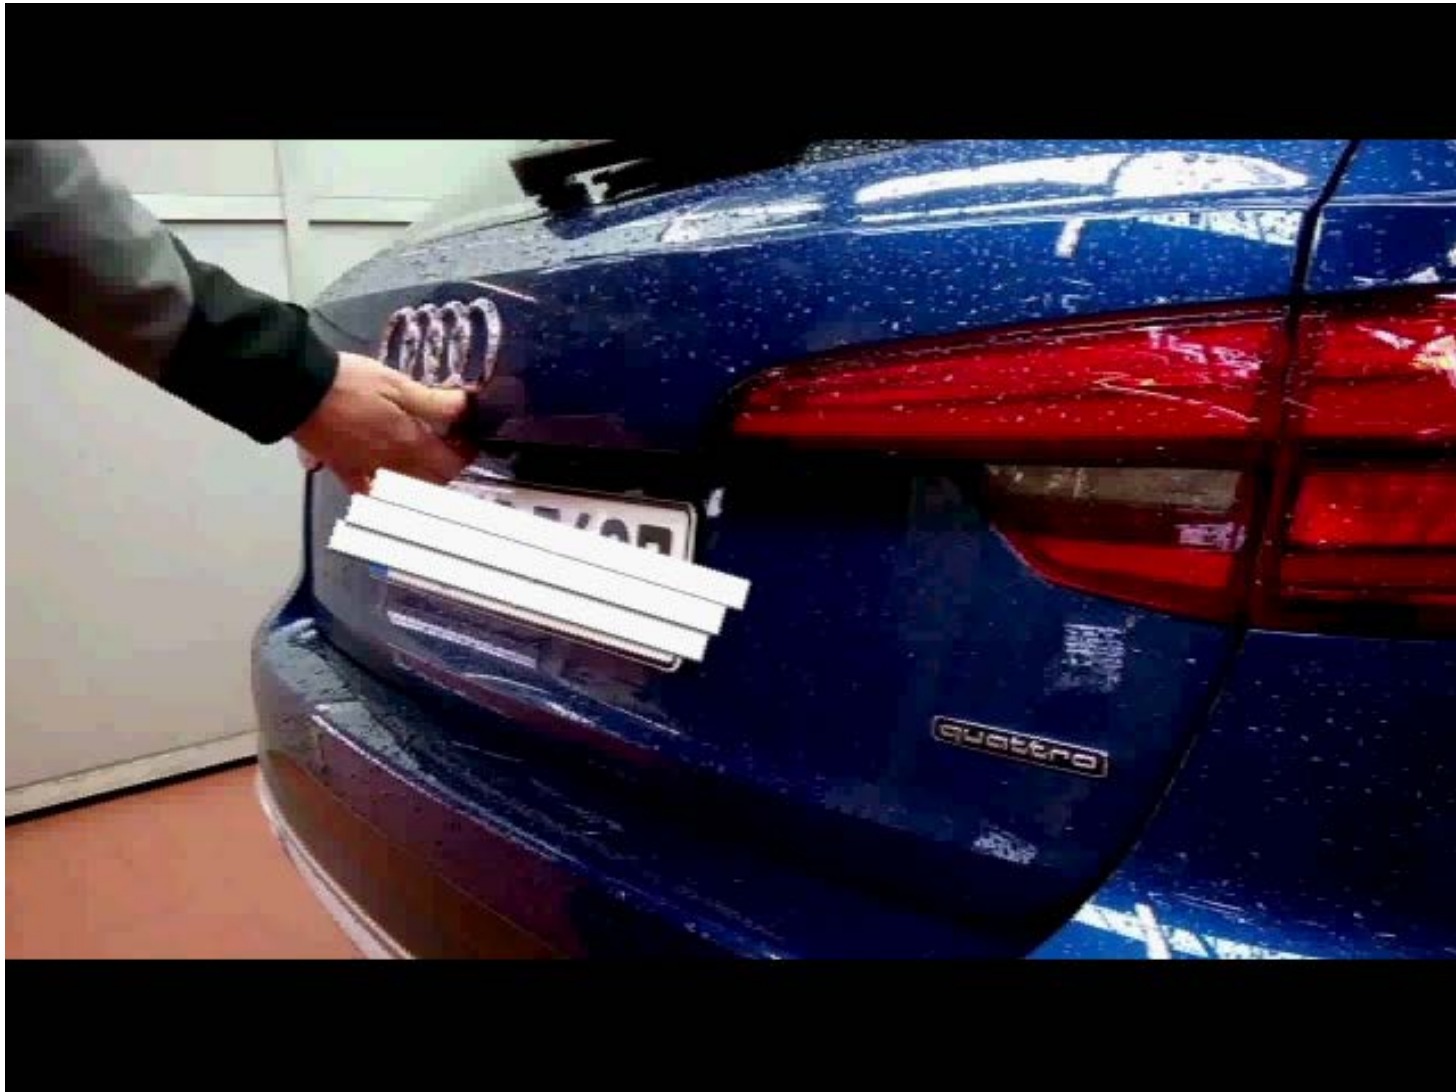
Rear lid lock sticks in first catch

Problem reported by customer/results found by workshop:

- › Replace rear lid lock.
- › There are no DTC(s) stored in the diagnostic memory.

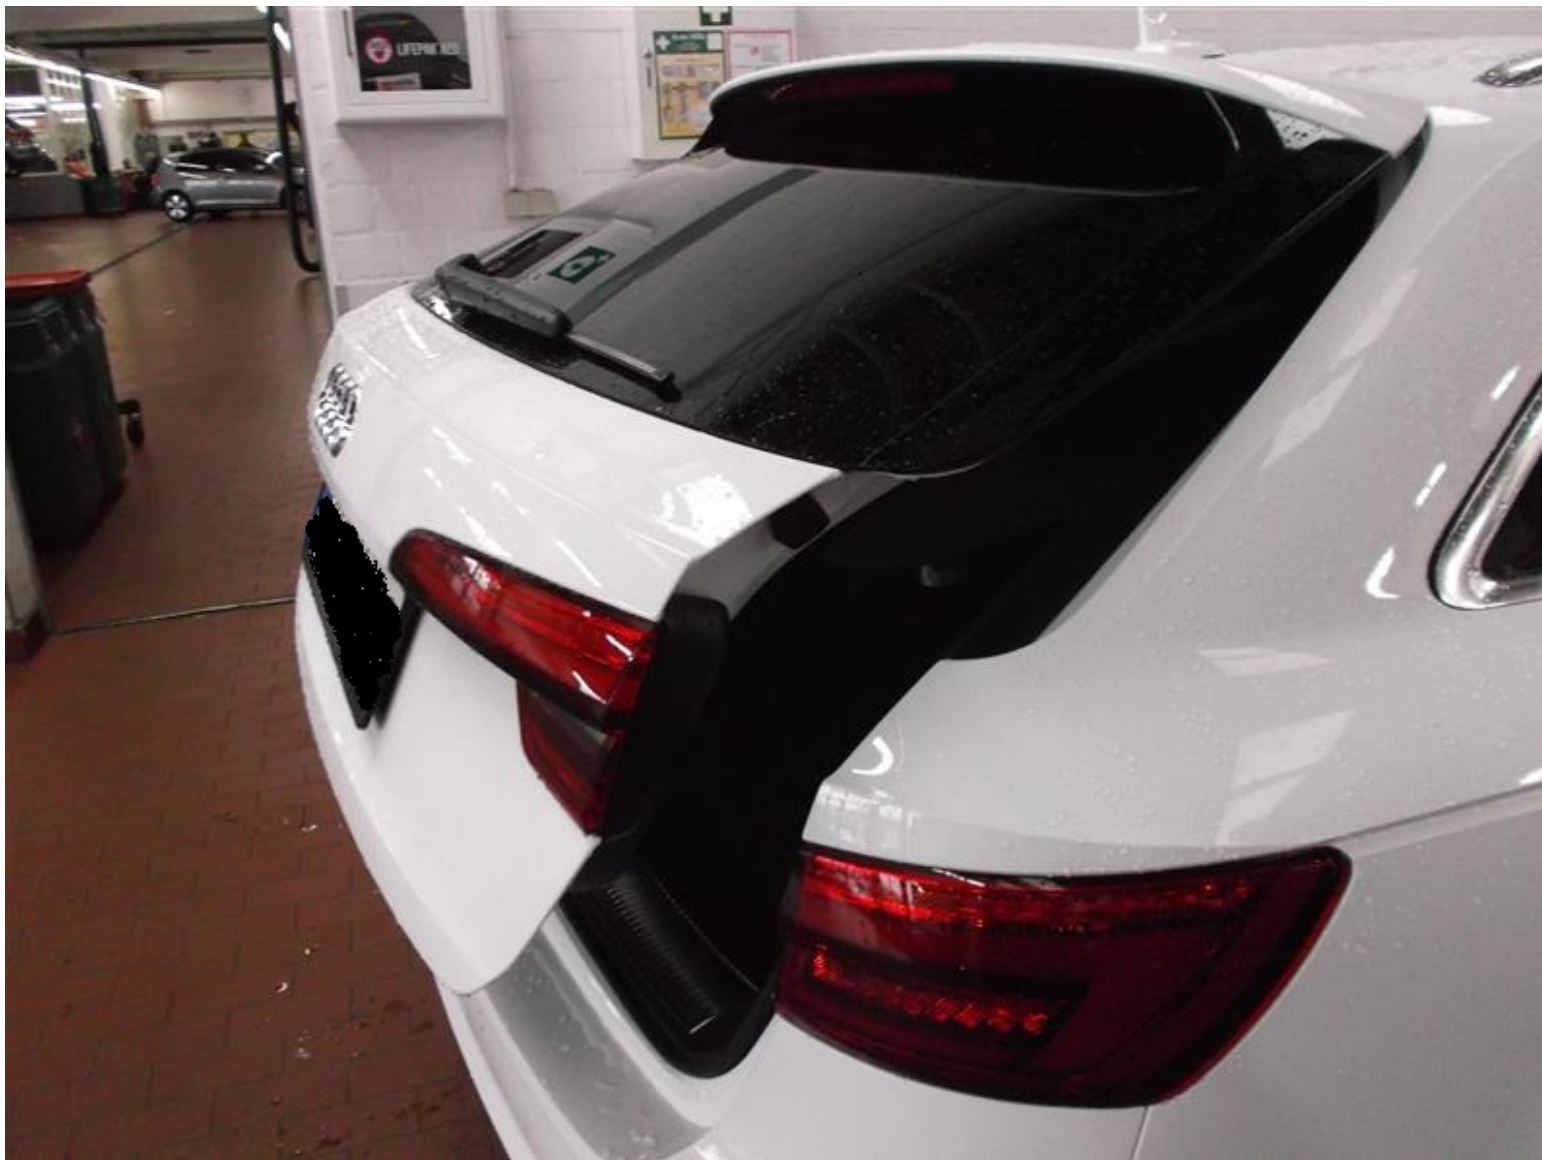
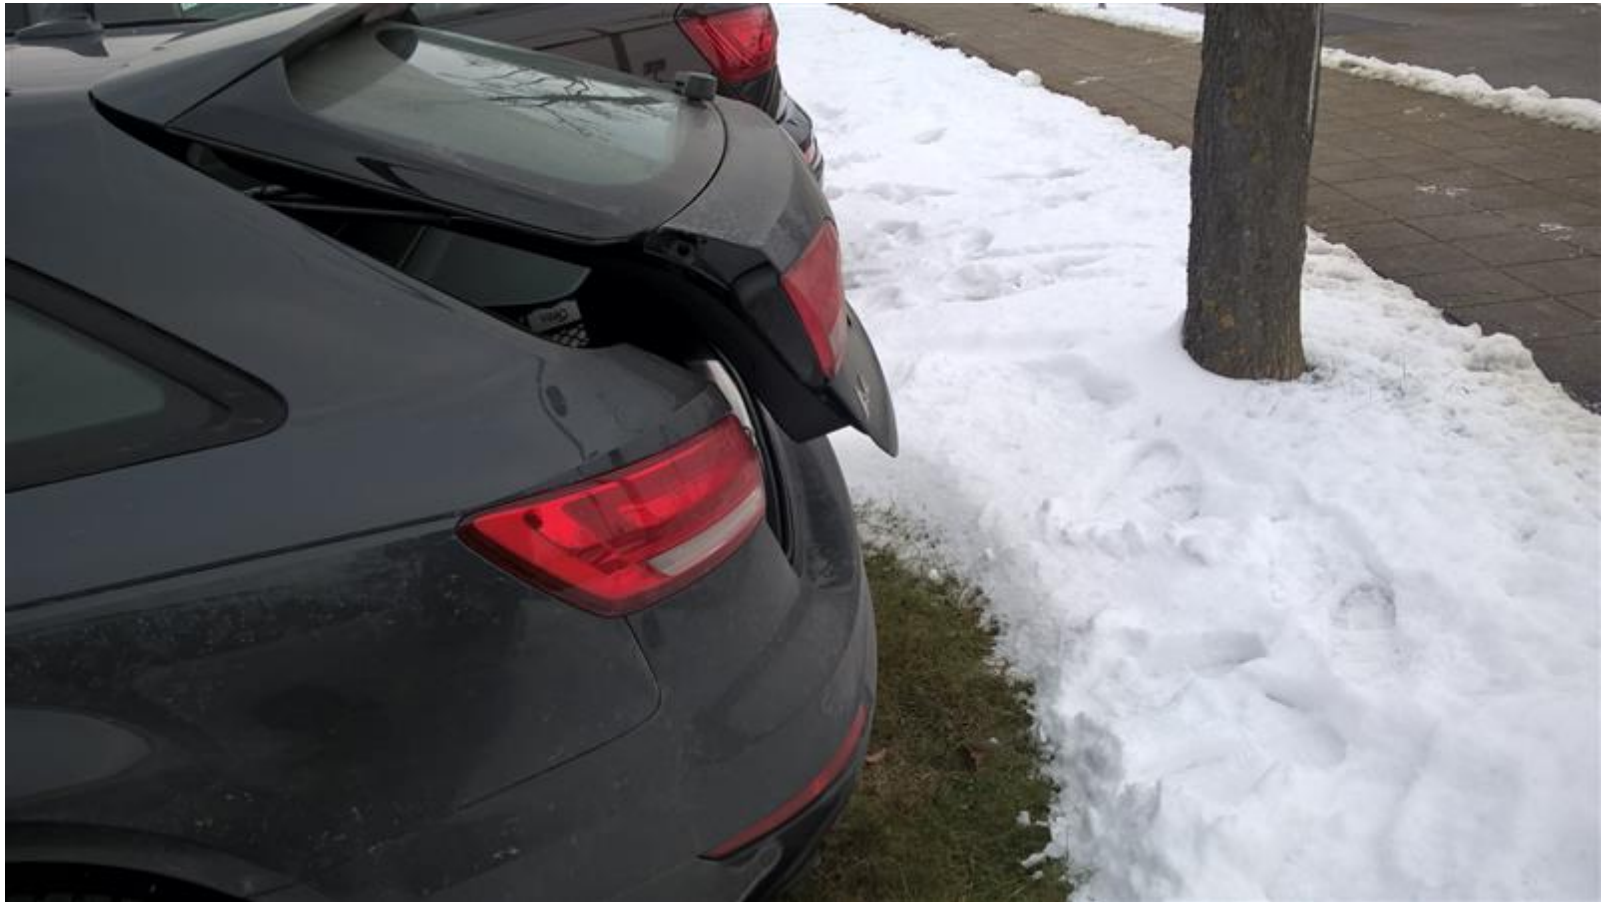
Rear lid only opens approximately 25 cm

- › There are no DTC(s) stored in the diagnostic memory.
- › Replace rear lid lock.

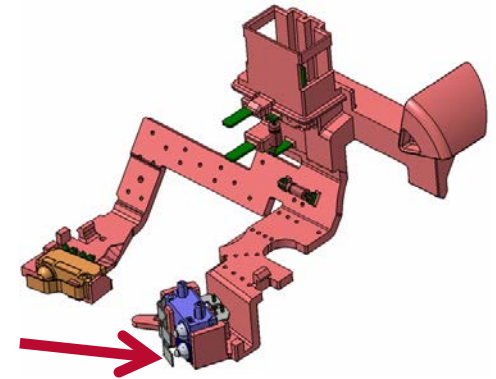
If the problem is constant, the rear lid lock status can be read out from the measured values in the rear lid control module, J605 (address word 006D).

- › Status of rear lid lock.
- › Rear lid lock in first catch.
- › Main catch open.
- › First catch closed.

As the problem often depends on the temperature, you can try to reproduce the problem by warming or cooling the rear lid lock:

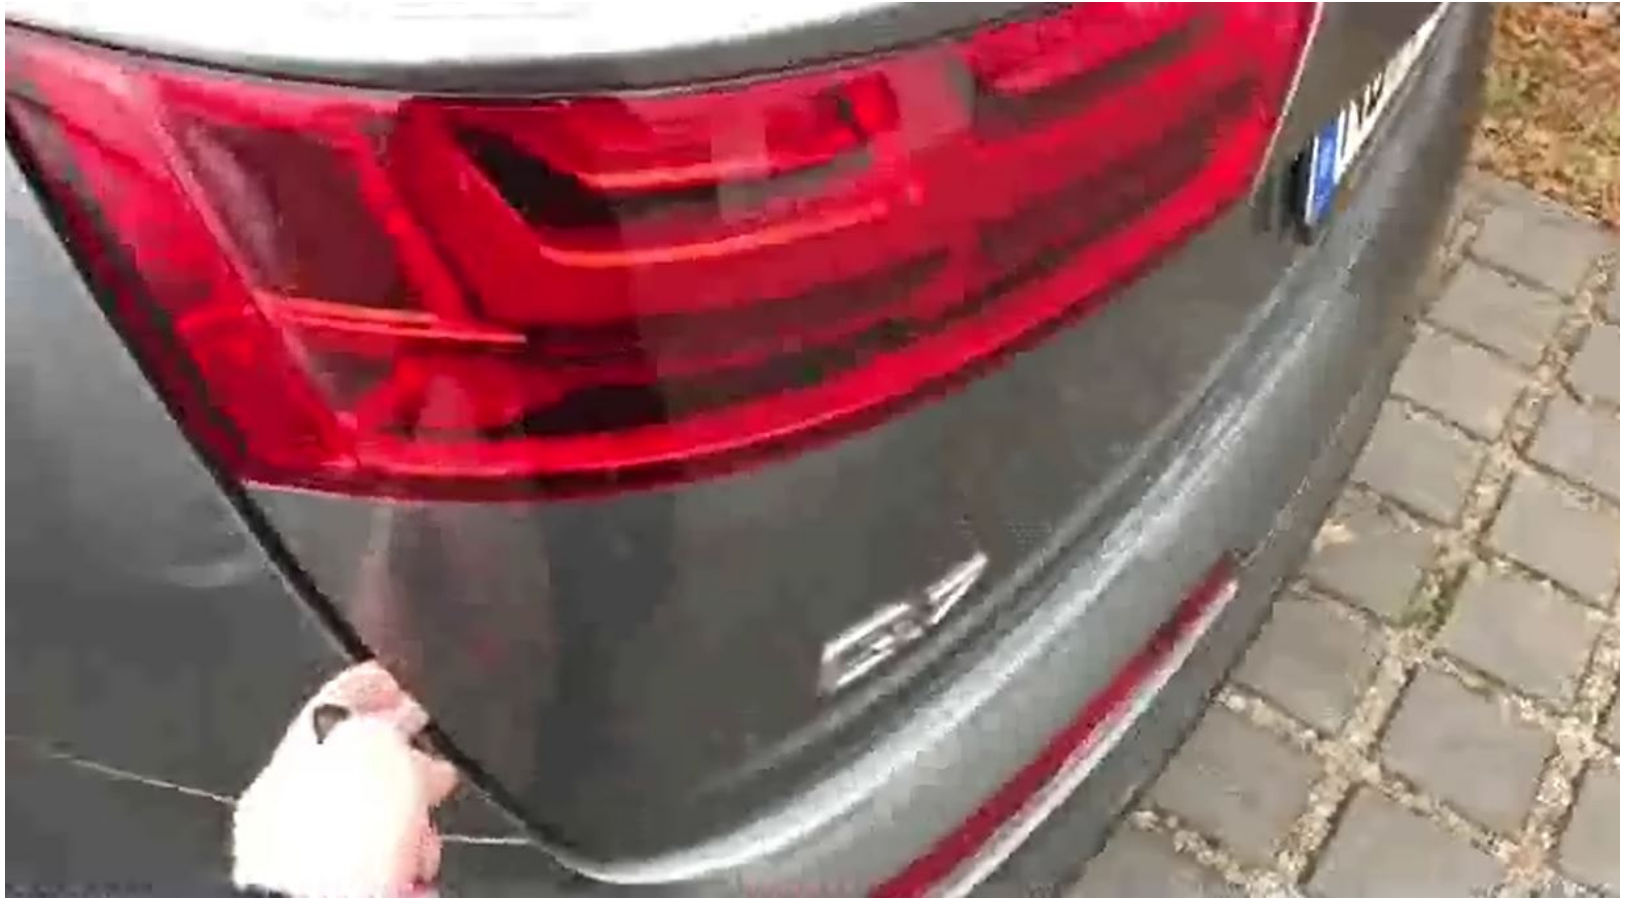
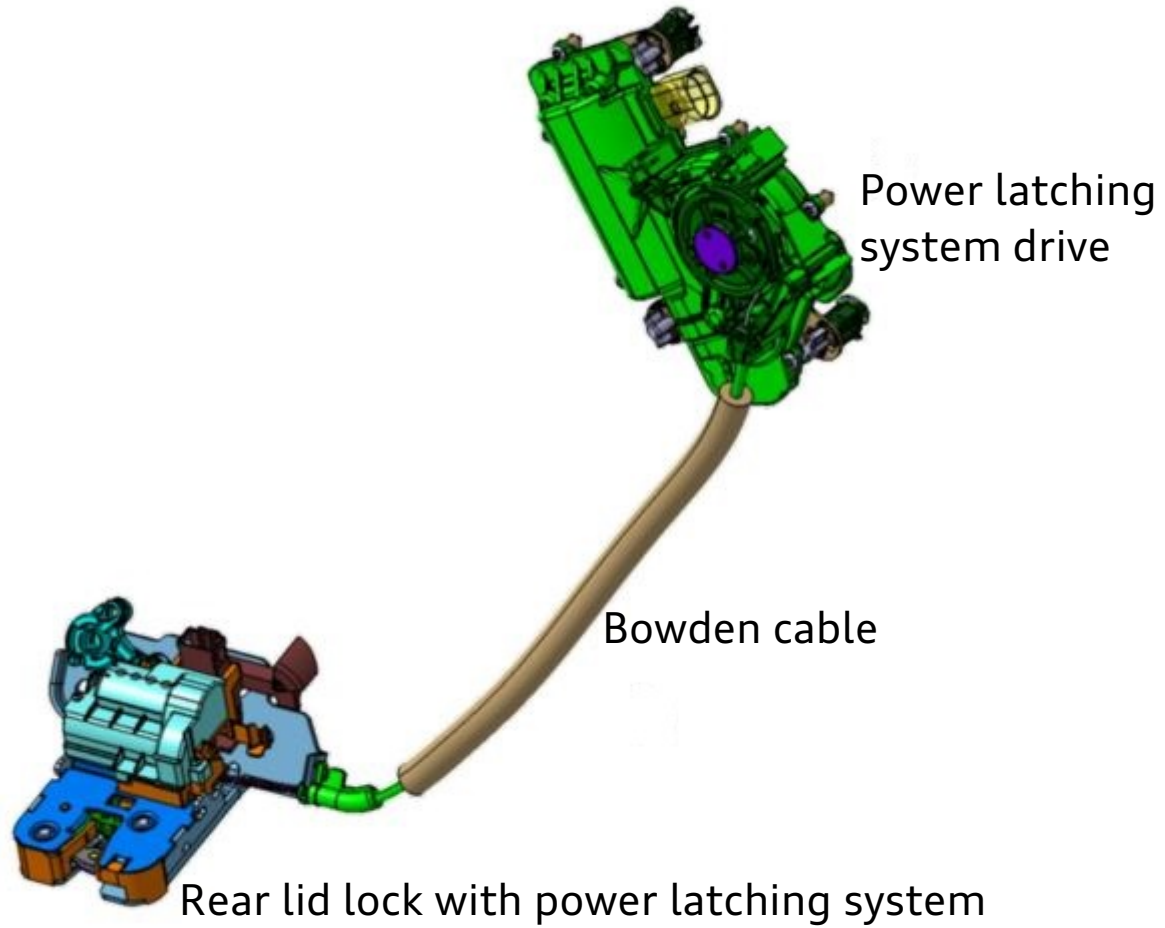
Rear lid is not pulled completely closed

Technical background of first possible cause:

Too great a tolerance in the screw shaft drive can cause the power latching system drive to stick. The power latching system drive does not reach the end position after it is operated. End switch for power latching system drive is not operated.

- If problem is constant, the **DTC B113E29** (Power latch – implausible signal – static) can be read out of the diagnostic memory of the rear lid control module, J605 (address word 006D).
- As the problem often depends on the temperature and only occurs after closing the rear lid a second time (after a longer period when the rear lid was not operated), the **DTC B113E29** (Power latch - implausible signal - passive/sporadic) may be stored in the diagnostic memory, or may have already been erased by the reset counter/driving cycle.
- Replace power latching system drive.

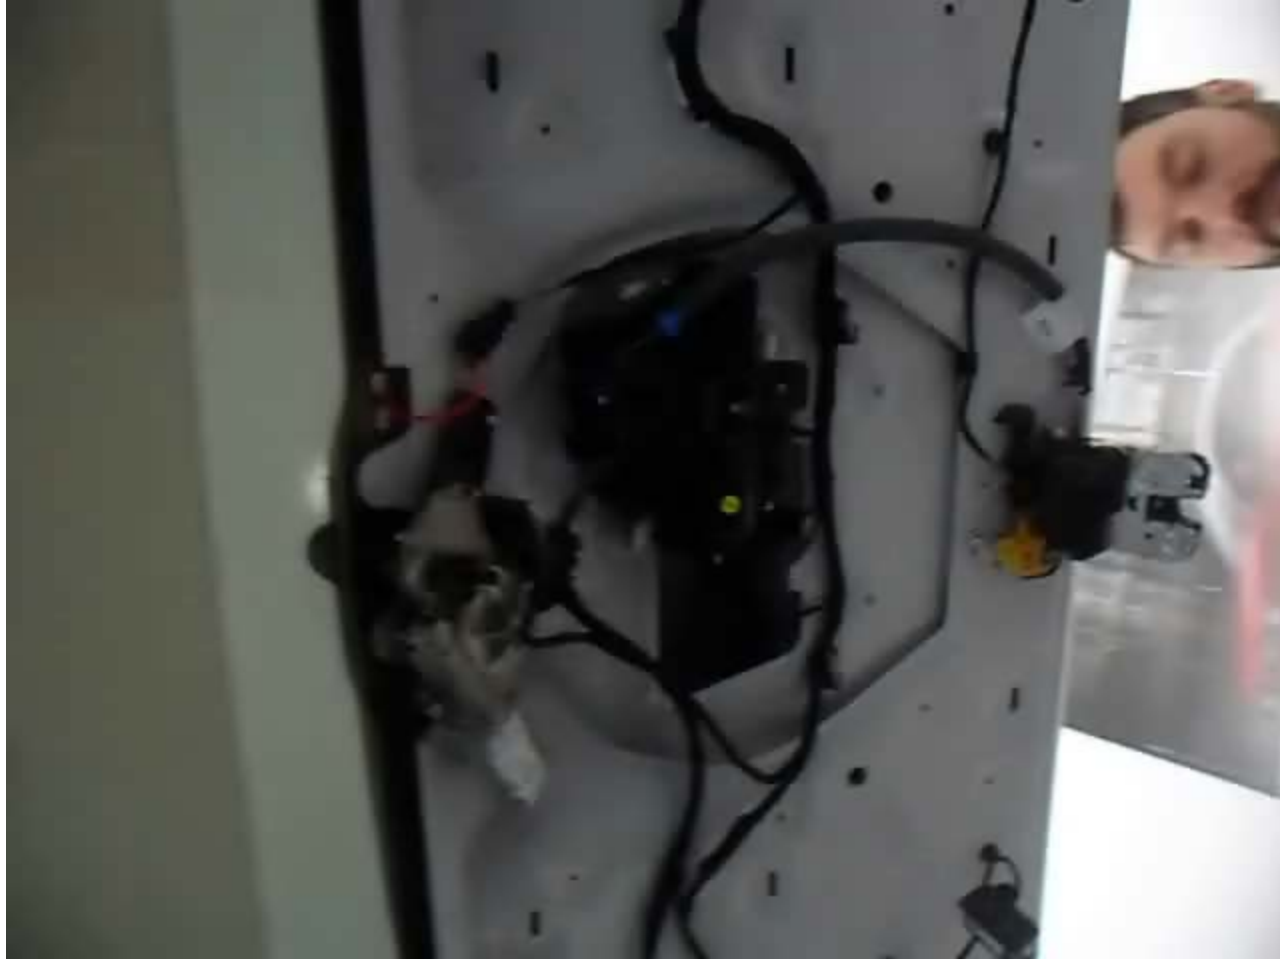
Rear lid is not pulled completely closed

Technical background of second possible cause:

A bent switch lug on the main catch microswitch can cause the microswitch to switch prematurely even though the rear lid lock is only closed as far as the first catch.

- Replace rear lid lock.
- There are no DTC(s) stored in the diagnostic memory.

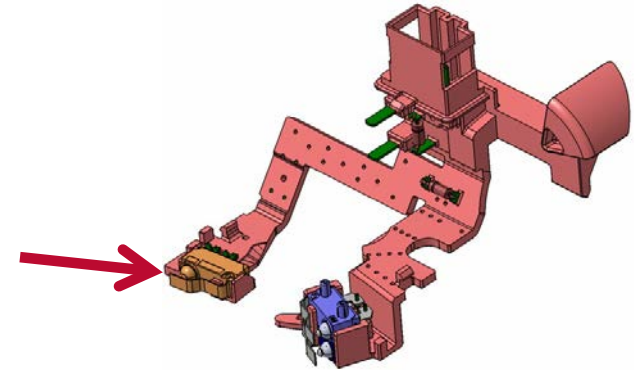
If the problem occurs, the rear lid lock status can be read out from the measured values in the rear lid control module, J605 (address word 006D).

- › Status of rear lid lock.
- › Rear lid lock closed.
- › Main catch closed.
- › First catch closed.

As the problem often depends on the temperature, you can try to reproduce the problem by warming or cooling the rear lid lock:

- › There are no DTC(s) stored in the diagnostic memory.
- › Replace rear lid lock.

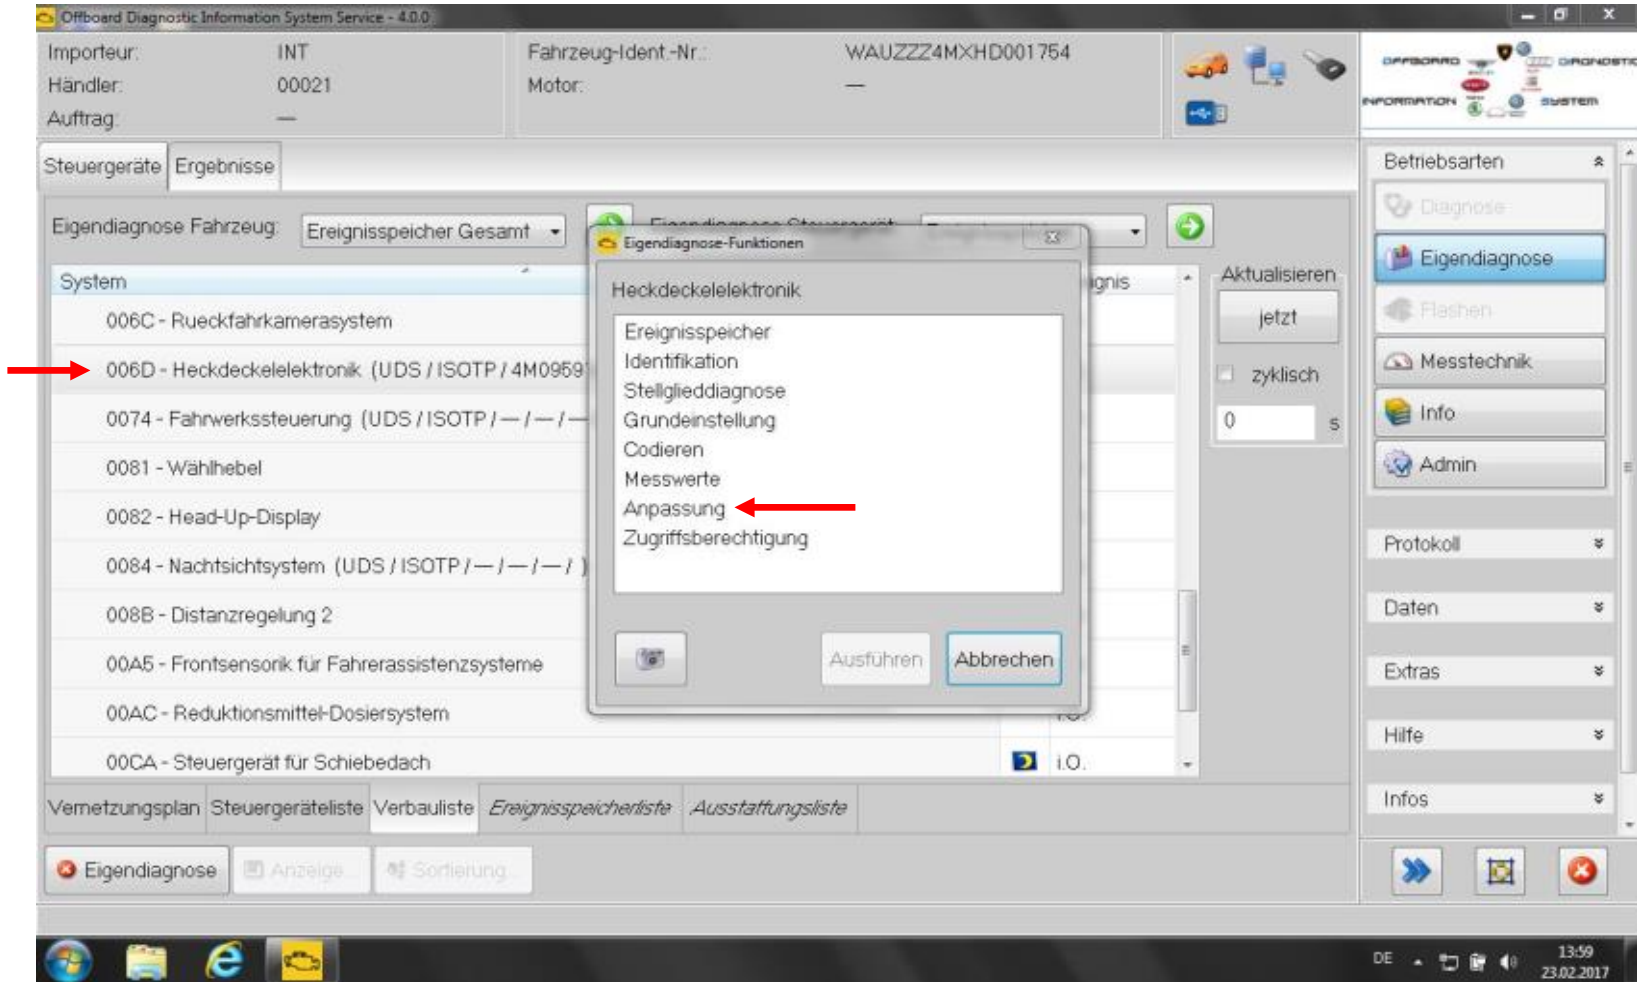
Rear lid does not open all the way

- When vehicles leave the factory, the rear lid has a small amount of play when it is completely open. The play increases if the opening height has been reprogrammed via the button in the rear lid trim.
- This is caused by play in the drive system and the value for the upper lock-in range that was entered at the factory. The result is that the maximum power-operated opening range can no longer be set.

Adjusting upper lock-in range

- 1) In self-diagnosis, select control module 006D rear lid electronics
From the self-diagnosis functions, select the "Adaptation" tab.
