AIR BAG LAMP ILLUMINATED. FAULT CODE 9309A0

F15 (X5 40e)

PHEV vehicles with N20 engine

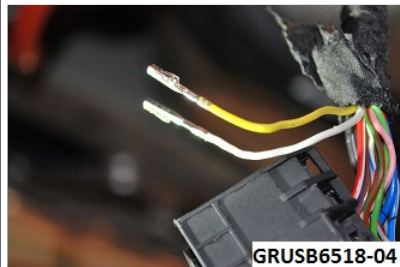
The wires going to pins 7 (CRASH +) and 20 (CRASH-) in connector A190*1B are under tension. Vibrations may sporadically increase the resistance values of these connections outside of the acceptable range leading to an air bag warning light being illuminated.

8. Replace pins 7 and 20 (use Part Number 12-52-7-560-889) at the EME connector.

To remove the pins use pin release tool 611102 from tool kit 611100 or its supersession 610322 from tool kit 610300.
