# Service Bulletin

**Subject:** Information on Vibration Analysis and Diagnostic

**Models:** 2014 Chevrolet Silverado 1500  
 2015-2017 Chevrolet Silverado 1500  
 2014 GMC Sierra 1500  
 2015-2017 GMC Sierra 1500  
 EXCLUDES HD Trucks

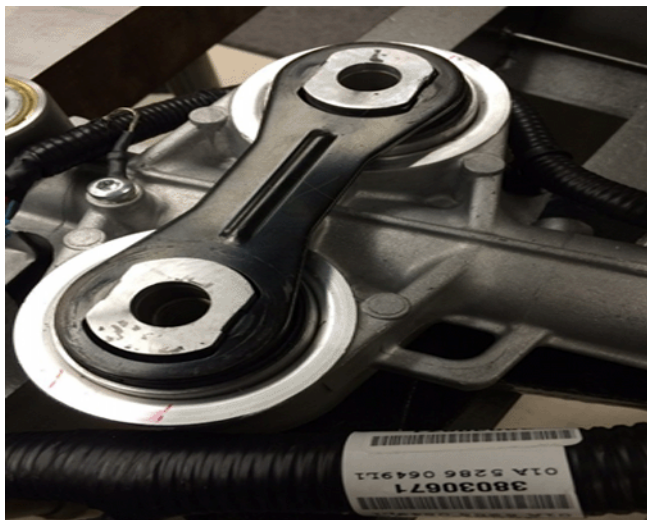
A revised steering bushing (2) has been released to address customer vibration concerns. After various testing and measurement of the T1 vibration, a vibration path from the tie rods =>steering rack=>steering bushings=>frame=>Body Mount=>Cabin Floor=>Seat has been identified. To help isolate the steering rack (1), a revised hydraulic bushing has been released and tuned to the T1 frequency. The new steering bushing dampens minor T1 vibrations. This is the reason that the causal part (normally the Tire/Wheel Assembly) must be corrected first. If the T1 vibration is over 20-25m/g's, the bushings will have little to no effect.

For vehicles with T1 vibrations under 20-25m/g's, replace steering bushing per parts catalogue. Utilize SI procedure "Steering Gear Mount Bushing Replacement" for replacement of the steering bushings.

**Warning:** Care must be taken to not damage the EPS Motor electrical connectors or gear replacement may be required.

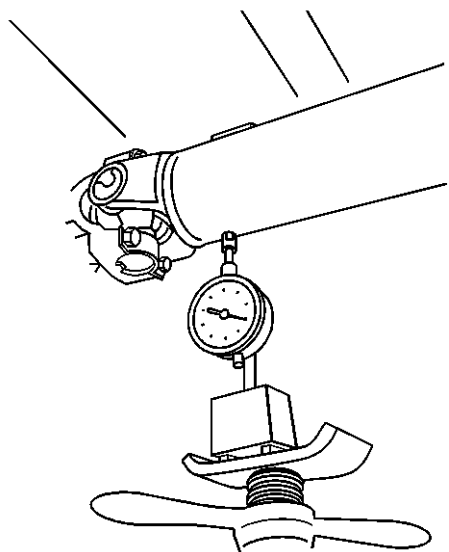
- This measurement procedure is intended to measure propeller shaft runout for prop shaft systems with 2 or 3 U-joints only. This is not for prop systems with only 1 U-joint, or with only constant velocity (CV) joints, and/or coupler assemblies.
  - When measuring runout of propeller shafts, do not include fluctuations on the dial indicator due to welds or surface irregularities.
1. Raise and support the vehicle with the wheels free to rotate. Refer to the Lifting and Jacking the Vehicle in SI.
  2. Place the transmission in NEUTRAL.
  3. Clean the circumference of the propeller shaft of any debris and/or undercoating along the rear of the shaft, where contact of the dial indicator will make to the propeller shaft.
  4. Inspect the propeller shaft for dents, damage, and/or missing weights. Any propeller shaft that is dented or damaged requires replacement.

5. Mount the GE-7872 Magnetic Base Dial Indicator Set, or equivalent, or the GE-8001 Dial Indicator Set, or equivalent, to the vehicle underbody or to a service stand positioned just clear of the U-joint yoke weld on the prop shaft.

6. Rotate the drive pinion axle flange, torque tube input flange, transmission output, or transfer case output flange by hand while take runout measurements of the prop shaft. The prop shaft will rotate more easily in one direction than in the other. If necessary, the tire and wheel assemblies and even the brake caliper assemblies can be positioned and supported aside, or the brake drums can be removed from the drive axle to provide axle to provide easier rotation of the prop shaft.

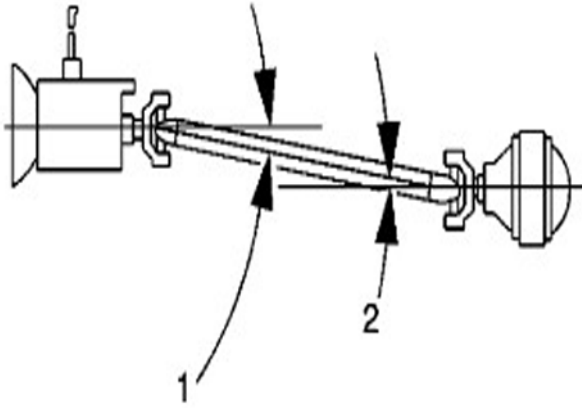
Measurement	Notes:
Yoke to Shaft		The first (forward most) U-joint action on a two piece driveshaft system is not canceled out by another U-joint. Because of this, the first U-joint working angle should be between 0.5 and 0.75 degrees.
Front Shaft to Center Support Bearing (if equip)		U-joint pairs cancel each other. Neither U-joint working angle should exceed 4 degrees, nor the allowable range of difference between cancelling U-joint working angles is 0.00 to 1.0 degrees.
Shaft to Diff Yoke

Propeller systems containing only 1 U-joint: The U-joint working angle should be between 1/2 and 3/4 degrees.

Allowable range of difference between cancelling U-joint working angles: 0.25 to 1.0 degrees.
