HYUNDAI Technical Service Bulletin	GROUP BODY ELECTRICAL	NUMBER 18-BE-007
	DATE MAY, 2018	MODEL(S) SEE BELOW FOR APPLICABLE MODELS
SUBJECT: CLOCK TIME INACCURACY (DISPLAY AUDIO)

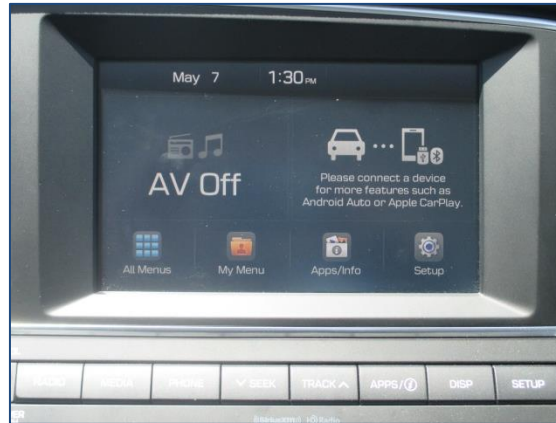
Description: This bulletin describes the procedure to determine if the vehicle’s display audio radio unit needs to be replaced as a result of the clock time inaccuracy (i.e. Resets overnight, loses/gains time).

SYMPTOM(S)
Clock mismatch

3. Check vehicle clock displayed at top center of radio display next day. If the difference between the vehicle clock is greater than 2 minutes (>2 minutes), replace the radio assembly.
