SERVICE BULLETIN

Classification: EL15-002i	Reference: NTB15-009i	Date: May 23, 2018
------------------------------	--------------------------	-----------------------

NAVIGATION SYMPTOMS WHEN SD CARD IS MISSING OR WRONG CARD INSTALLED

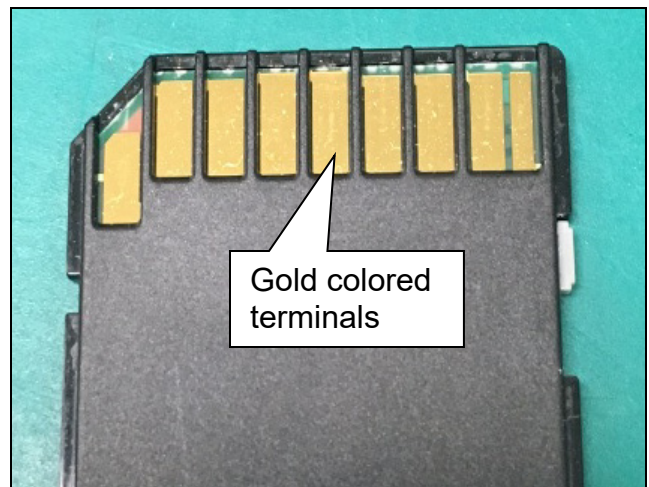
Figure 7

- Do not touch the gold colored terminals.
- When closing SD card cover, do not push from the center. This may cause the card to partially eject.
