2nd row seat chirp/squeak noise from the rear seat latches

2011-2018MY Sienna (8 passenger type)

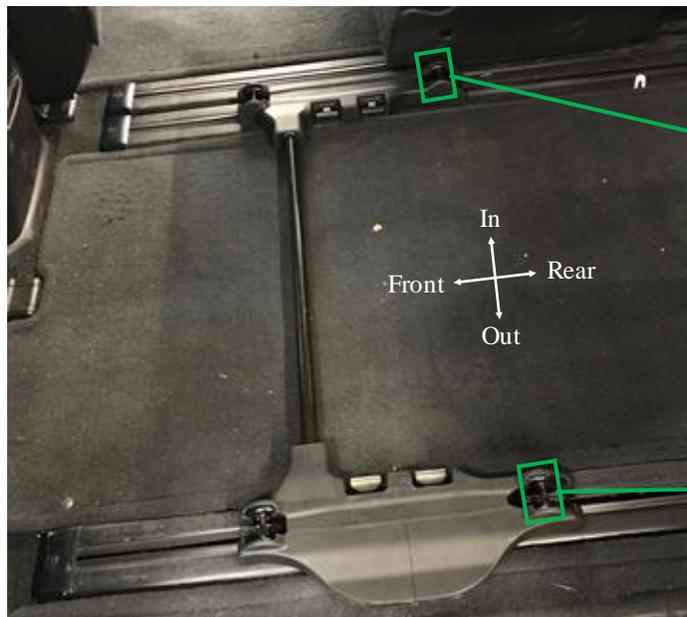
Fig.1 Overall of seat latches (floor area)

Some vehicles may experience a condition in which the 2nd row seat, with center seat, exhibits a chirp/squeak noise from the rear seat latches (floor area). This condition is present while driving over rough or bumpy roads. Upon further inspection, after removal of the LH 2nd row seat, the rear inboard and outboard strikers may show signs of the coating peeling off as shown in Fig.2 and Fig.3.

1. Please document the following:
 - a. Photograph the 2nd row, rear inboard and outboard strikers as shown in Fig.2 and Fig.3.
 - b. Inspect condition of cushion bumper attached to rear inboard and outboard seat latches and photograph as shown in Fig.5 or Fig.6.
