## JTB00527NAS3 TECHNICAL BULLETIN 23 MAY 2018

415-01: Information and Entertainment Systems

Disc Does Not Eject From The Digital Disc Player

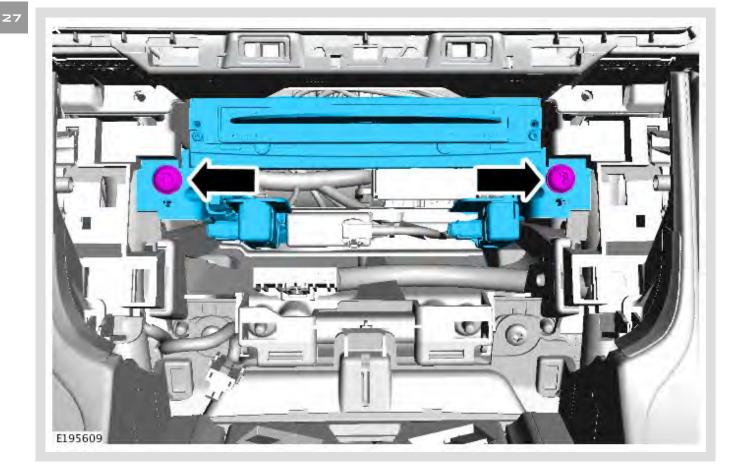
Remove the digital disc player, withdrawing the unit to view the wiring harness connections.

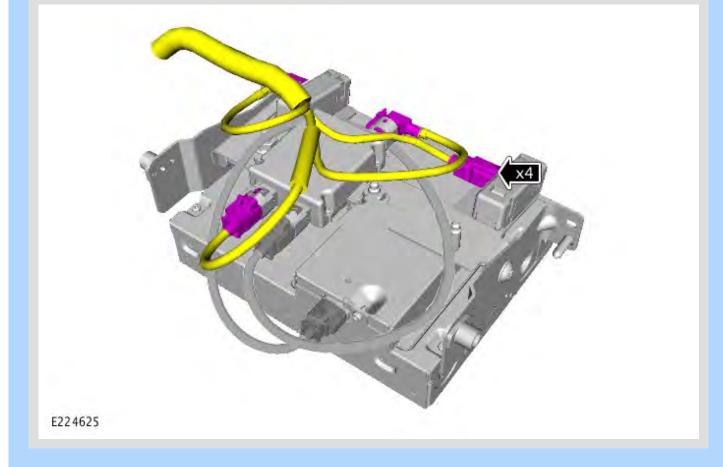
The connections MUST be installed as shown. Failure to do this may damage the component.

Install the electrical connectors to the USB 2.0 hub and Wi-Fi/Bluetooth™ antennas as shown
