# TECHNICAL BULLETIN 23 MAY 2018

415-01: Information and Entertainment Systems

Disc Does Not Eject From The Digital Disc Player

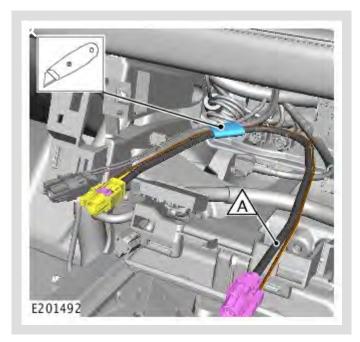
Cut the tape in the position shown.

1 Remove and discard the spot tape and original front link lead 'A'.

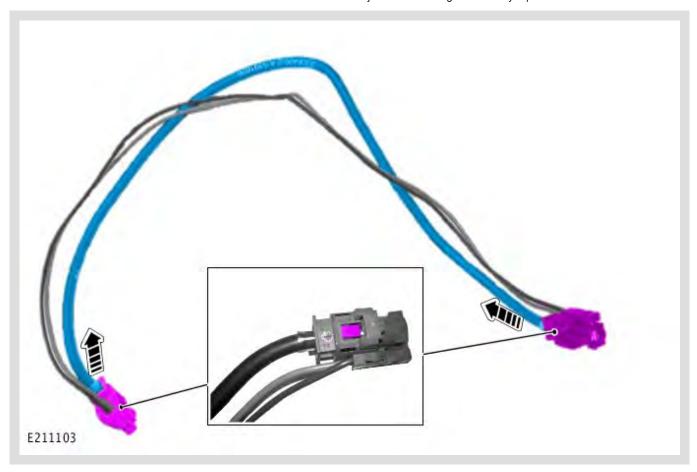
Release the electrical connectors from both ends of the original USB link lead.

1 Discard the original black coaxial USB link lead.

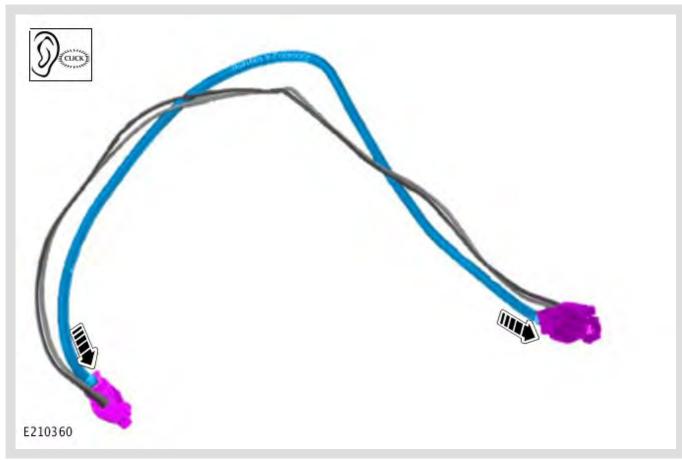
Install the replacement black coaxial USB link lead into the original electrical connectors.

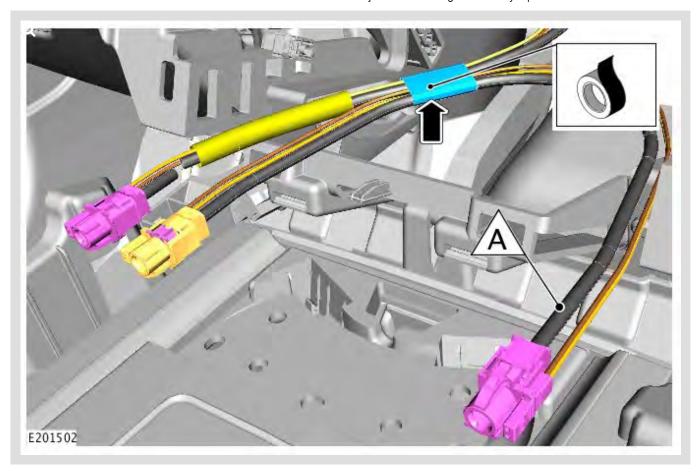
Install the new front link lead 'A', using suitable tape secure to the original wiring harness.

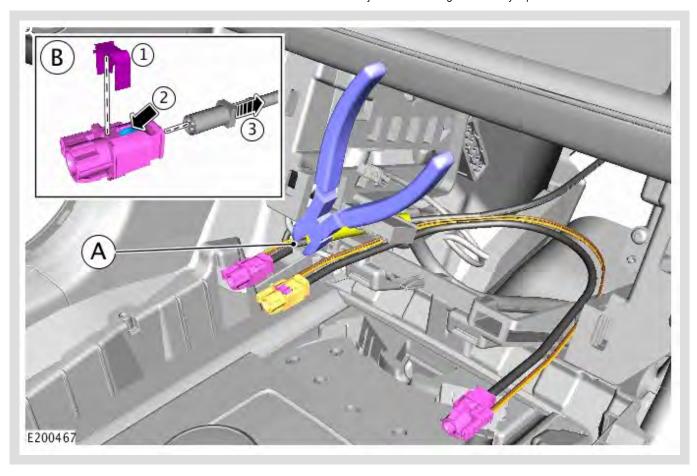
Use a suitable tool to cut the IMC rear link lead cable 'A'.

1 Use the sequence (1 - 2 - 3) in the illustration to remove the remaining cable from the electrical connector 'B' and discard.

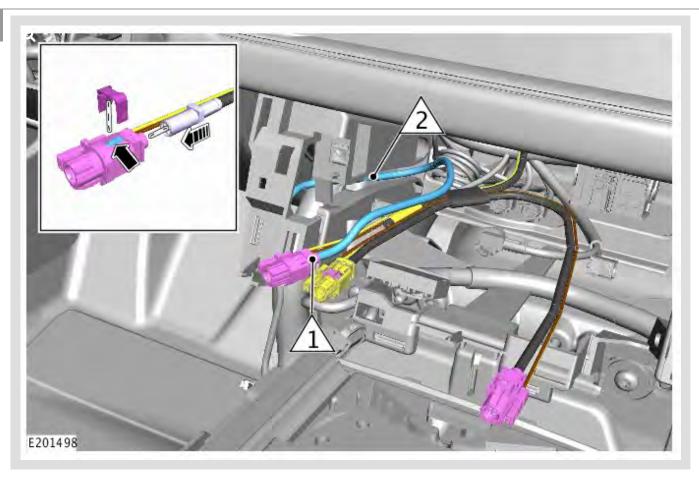
Install the new IMC rear link lead cable into the original electrical connector (1) and route the new cable with the main instrument panel harness (2).

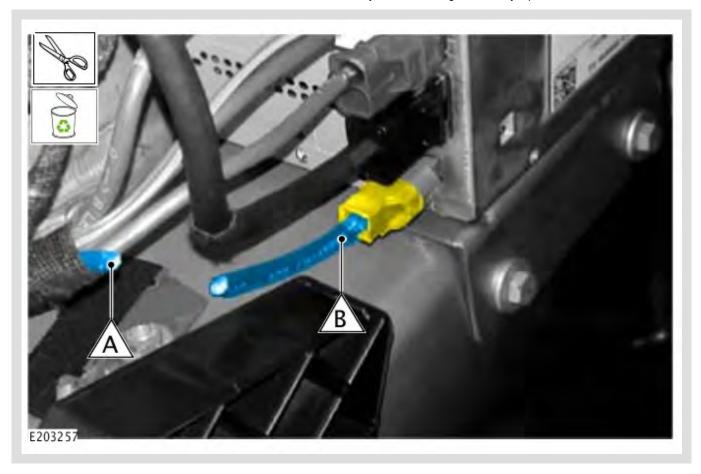
Make sure to only cut the original IMC rear link lead.

Cut the original IMC rear link lead cable in a suitable position (A).

1 Unplug the cable connector and remaining cable (B) from the IMC and discard.

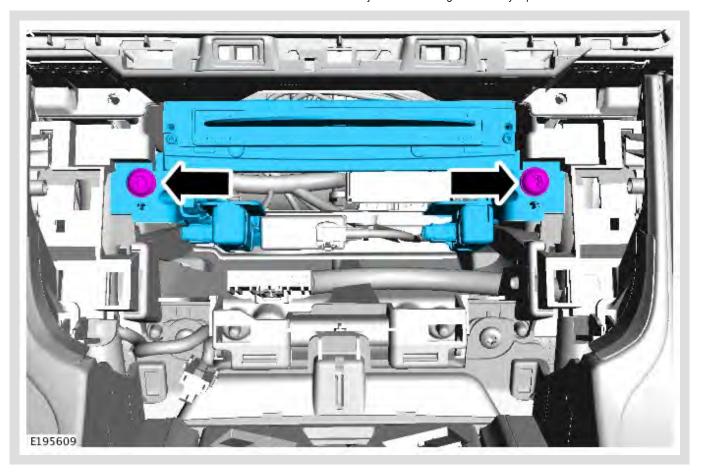
Make sure the wires are routed correctly when installing the digital disc player.

Install the digital disc player.
