**Countries:** CANADA, UNITED STATES **Document ID:** IK0800538  
**Availability:** ISIS, Fleet!SIS, IsSIR **Revision:** 1  
**Major System:** ELECTRICAL SYSTEM **Created:** 3/10/2017  
**Current Language:** English **Last Modified:** 5/29/2018  
**Other Languages:** NONE **Author:** Charles Schroeder  
**Viewed:** 1558

**Title: ProStar SCR Aftertreatment Harness Replacement****Applies To: ProStar with SCR (ISX and N13)**

The PDM in the Aftertreatment has been updated. When a harness with an old style PDM is replaced with a harness containing the updated PDM the harness installation changes. This article will outline the details of the installation.

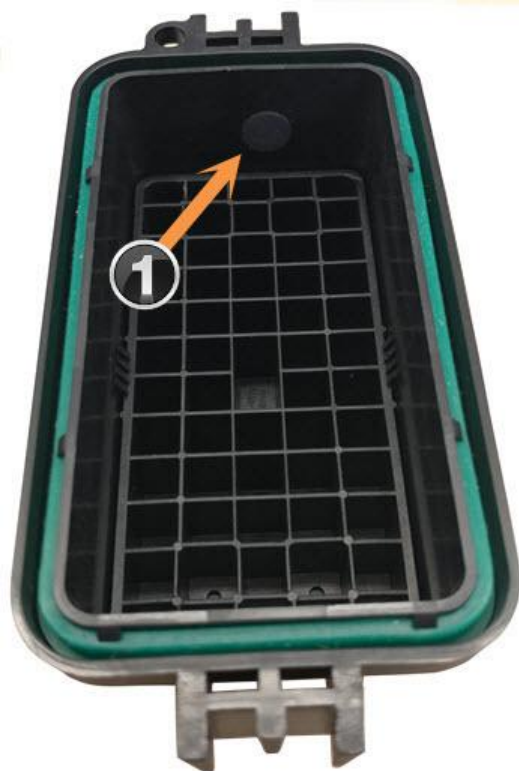
| Kit Description | Part Number | Quantity Required | Notes |
|---|---|---|---|
| COVER W/ VENT HOLE | 2519458C1 | 1 | The harnesses have been updated to use a vented lid to prevent corrosion within the PDM. If the harness does not have a vented lid, one needs to be installed |
