**Stoughton Trailers, LLC**

May 3, 2018

### Ag Hopper Trailer – Slope Sheet Repair

Repair Document #: **SK-09435**  
Date: April 16, 2018  
Revision:  
Revision Date: N/A

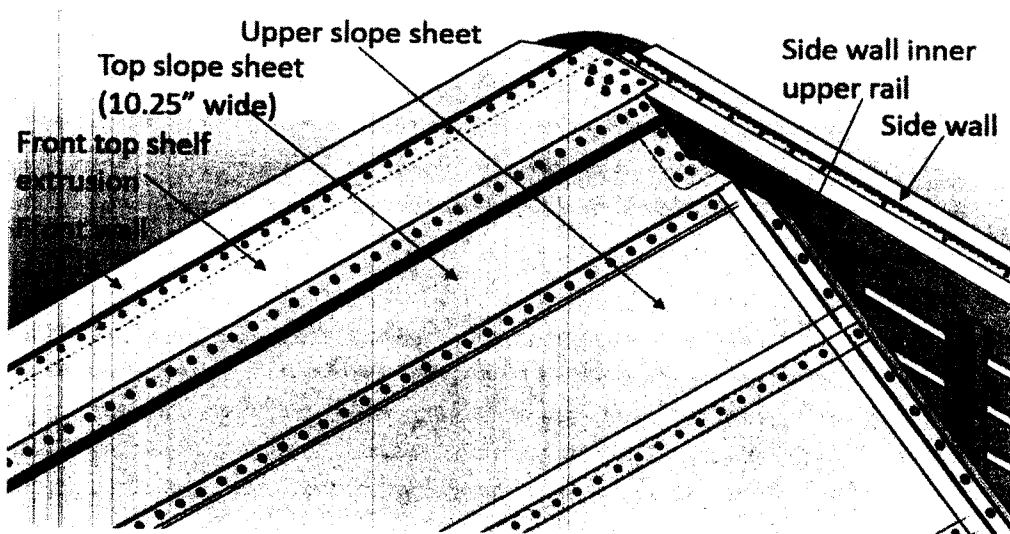
The repair and upgrade addresses inadequately chosen fastener that connects front top slope sheet (6.75" wide) and upper slope sheet. Failure of this fastener causes these two sheets to crack right under side top rail near side walls (see images).

- Front wall tarp cap
- Front top shelf extrusion
- Top slope sheet (6.75" wide)
- Upper slope sheet
- Missing fasteners

The upgrade will be performed at the front (front and rear on 40' long trailers) top shelf, top slope sheet (6.75" wide) and upper slope sheet. Top slope sheet (6.75" wide) and all of the connecting fasteners will be replaced. Front top shelf to front top rail fasteners need to be replaced. Top slope sheet will become 10.25" wide instead of 6.75" wide, this new sheet will eliminate a line of fasteners that failed on the picture above (circled). If damage already occurred, upper slope sheet will need to be replaced and slope rails checked for cracking. See below.

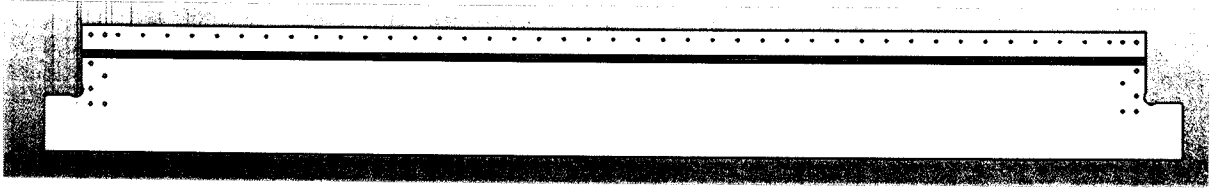
**Revised top slope sheet (10.25" wide) will look like this (See below).**

Transfer drill (43) 17/64" holes into top slope sheet (10.25" wide). Fasten with (43) 04-97100-000-00 pins and 04-97116-000-00 collars

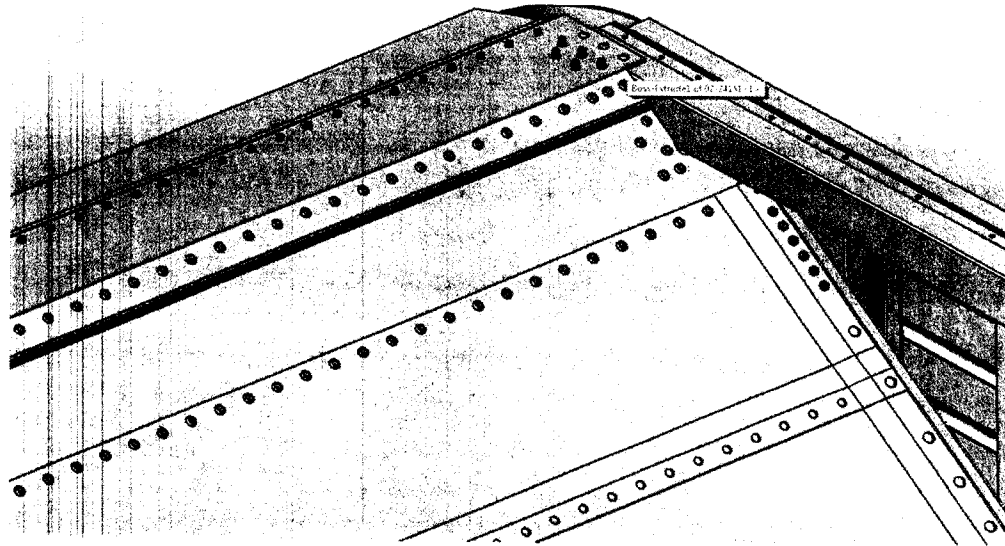
**Completed front slope of the trailer that has been damaged will look like this (See below).**

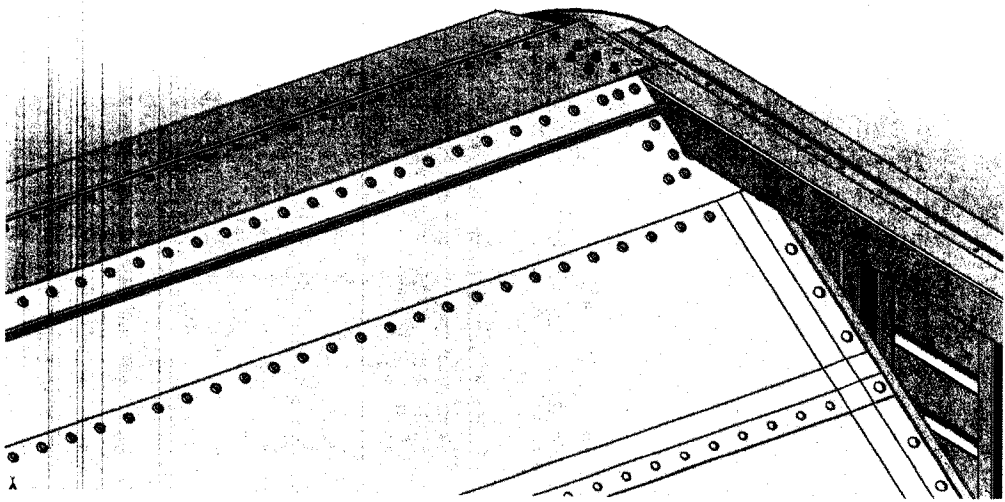
**Completed front slope of the trailer that has not been damaged will look like this (See below).**
