Special Bulletin

SP18-24

BELLEVILLE WASHER ADDITION ON SLIDE-OUT

Prevost vehicles

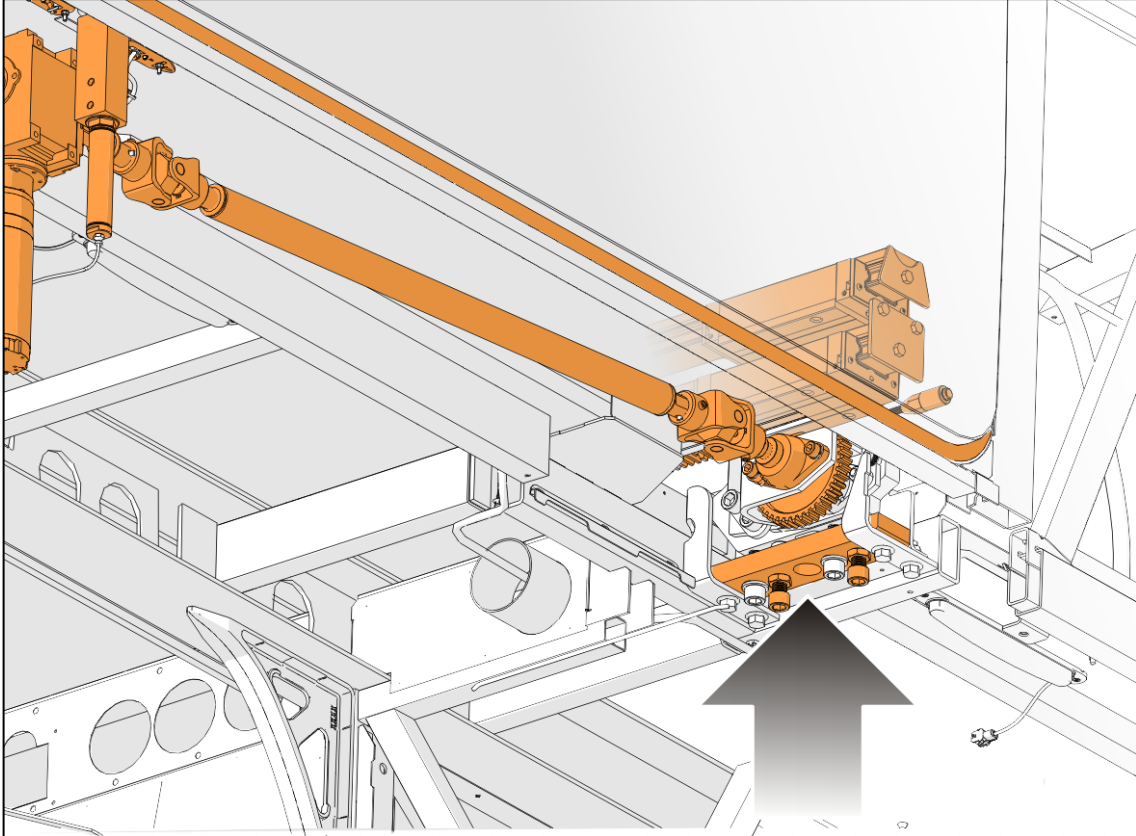
Figure 1: Tilting and leveling plate (Front plate shown)

1. Close the slide-out. Locate the tilting and leveling plates under the slide-out on each side. (Arrow, Figure 1)

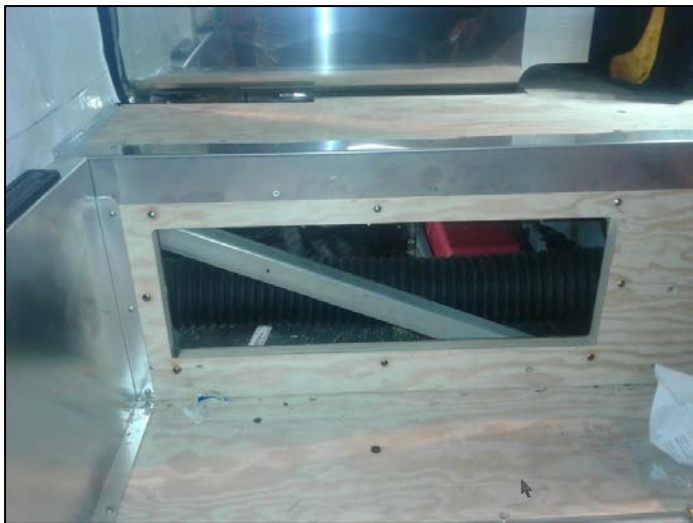
Figure 2: Access hatch

2. Inside the vehicle, remove the front passenger's seat (if present) and remove the slide-out mechanism access hatch behind the seat.

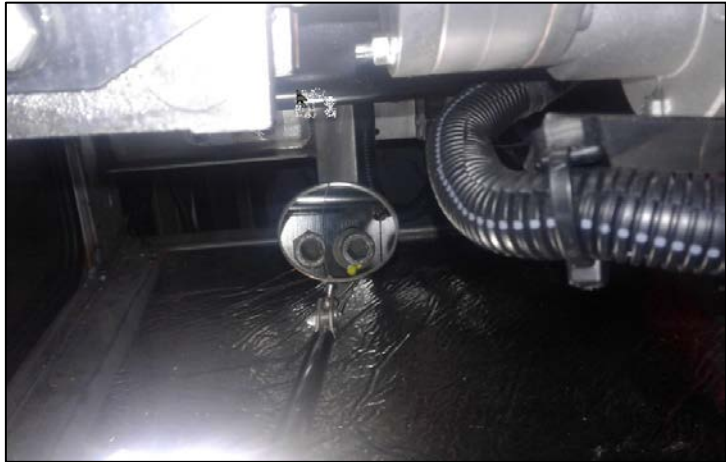
Figure 3: Using a mirror to locate the screws

3. Use a mirror and light to locate the screws.(Figure 3)

IMPORTANT: To preserve the slide-out adjustment, follow the proposed removal order, screw A then screw B.

4. Remove screw **A** (Figure 4).
5. Add missing washer 5002082.
Tighten to **55-65 lb-ft (75-88 Nm)**
6. Remove screw **B** (Figure 4).
7. Add missing washer 5002082.
Tighten to **55-65 lb-ft (75-88 Nm)**
8. Re-install access hatch and seat.
